**BUILDING SURVEY**

# Example Property

David Toogood FRICS, IRRV,  
ACI Arb

Saturday 28th July 2018

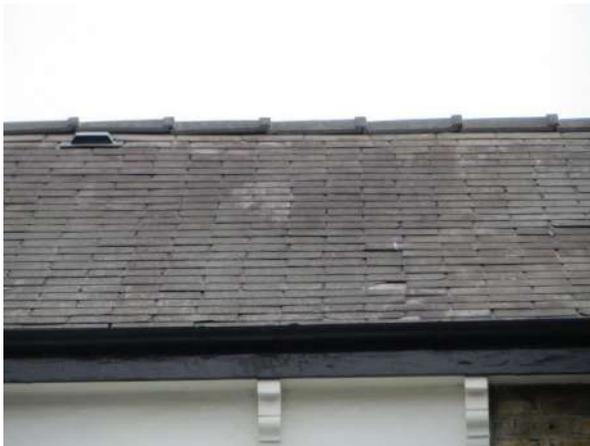
The front roof slope has been covered with grey Welsh slate. This is in poor condition, and several slates had slipped and are in need of immediate replacement. This will cost approximately £900. The remaining slate covering will need to be stripped off and be re-slatted in the long term.

Photo 3 - Front roof slope

We would estimate the cost of re-slating the pitched area of the front & rear roof to be approximately £15,000.

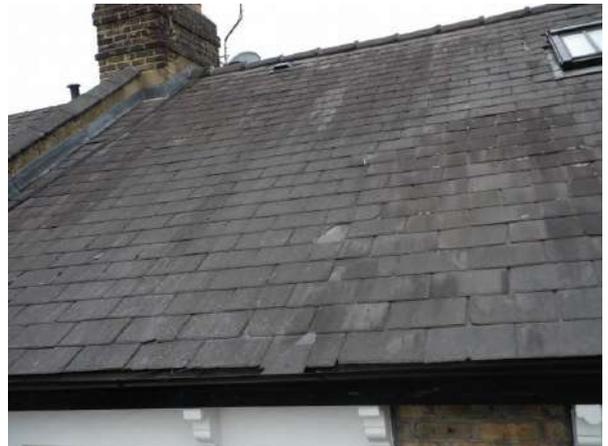
Photo 4 - Slipped slate

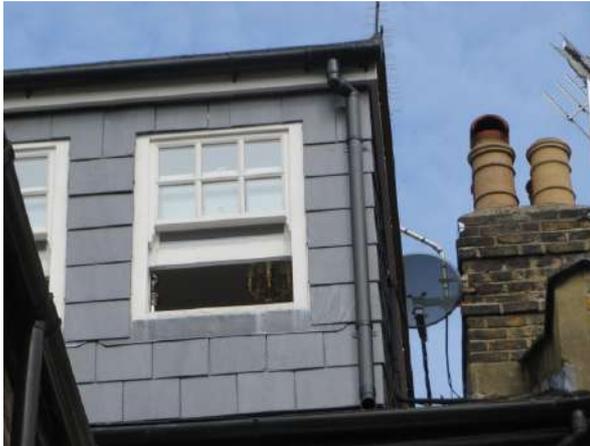
The rear roof slope is also covered with slate. This was in fair order and condition but is of the same vintage as that on the front and will have a relatively limited life expectancy of say 10/15 years before recovery is needed. The slope was interrupted by a large dormer window clad in slate which was in reasonable condition.

Photo 5 - Rear Mansard

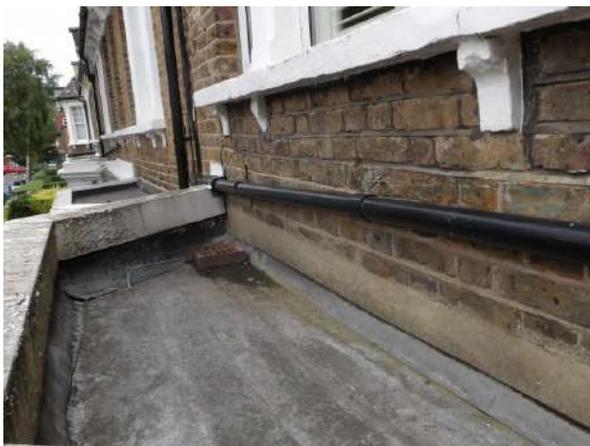
The bay window roof is flat and has been covered with asphalt that was in good order but is of some age. The asphalt is intact but we recommend that it is painted over with a heat reflective paint to preserve its longevity at a cost of approximately £500.

Photo 6 - Bay window roof

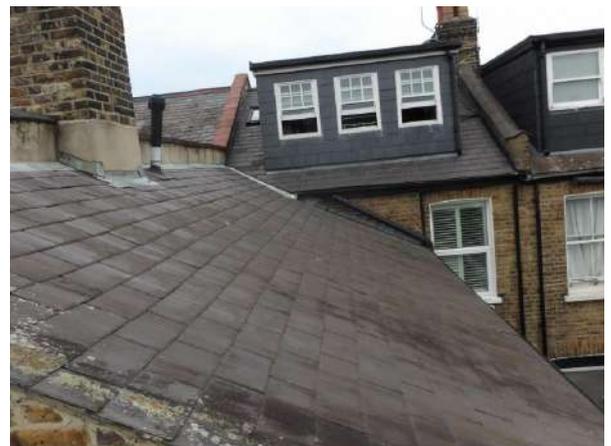
The rear addition roof is a mono pitched roof running from the right hand party wall down towards the flank wall and has been covered with slates. These appeared to be in adequate condition although there was some slight staining noted towards the rear of the rear extension. This is not considered to be significant.

Photo 7 - Rear addition roof

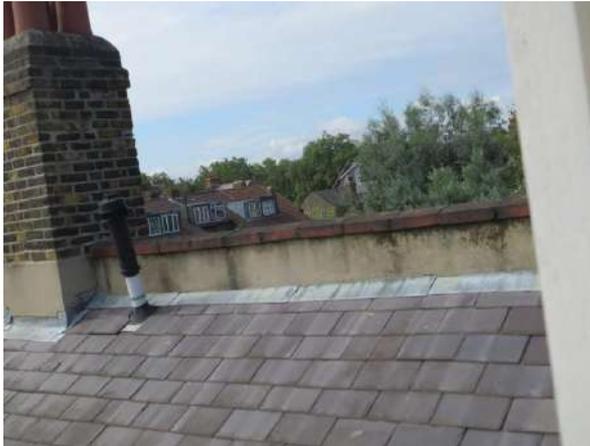
The junction of the pitched roof and wall/main roof is sealed with a lead flashing which appeared to be in good order and condition..

Photo 8 - Flashing detail

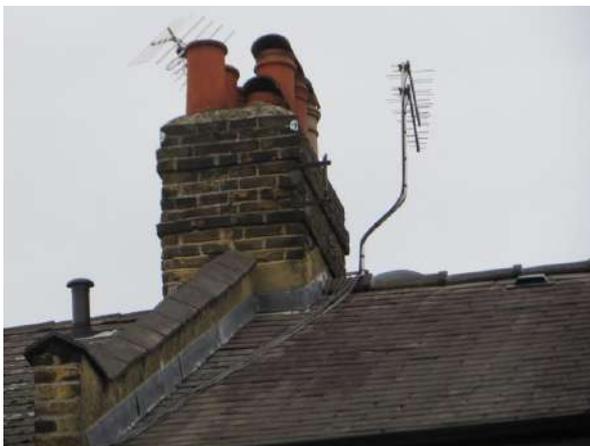
The main chimney stack is located on the left hand party wall and is a conventional brick built unit featuring over sailing courses and terracotta and clay chimney pot. The stack is weathered as expected in this exposed location but was in reasonable condition.

Photo 9 - Main chimney stack

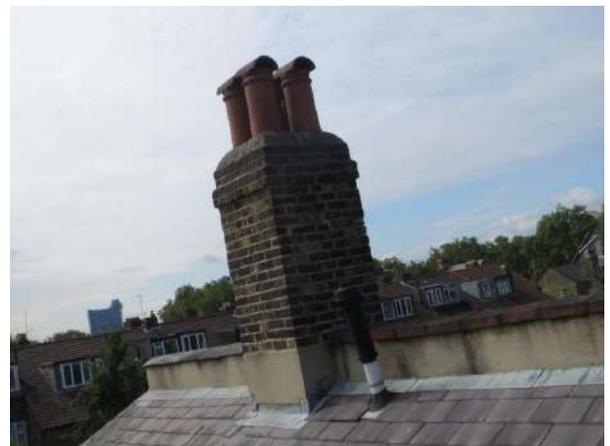
To the rear addition there is a similar brick built chimney stack with terracotta pots that have been sealed. This was also seen to be in reasonable condition.

Photo 10 - Rear addition chimney stack

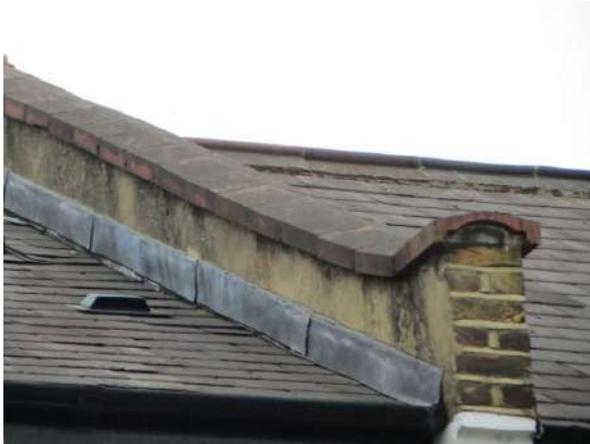
The party parapet walls on the front elevation comprise solid brick rendered on the inner face and capped with bonnet tiles. The bonnet tiles are somewhat uneven but are well bedded and in satisfactory condition.

The render covering is cracked in places and patch repairs are required in the medium term at a cosy of approximately £800.

Photo 11 - Front parapet wall

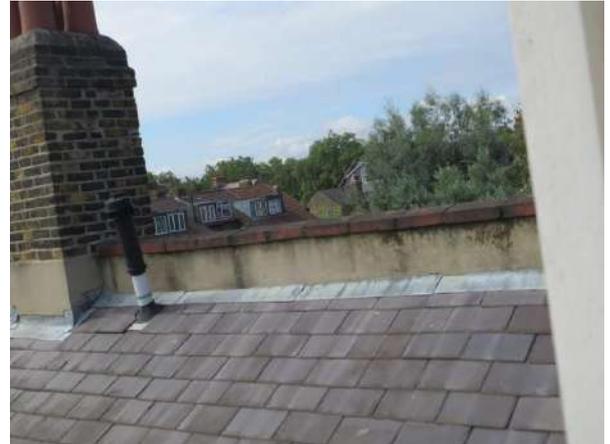
On the rear elevation the party parapet walls to the main building and the rear addition are similarly constructed of bonnet tiles, which were noted to be in satisfactory condition.

Photo 12 - Rear addition parapet wall

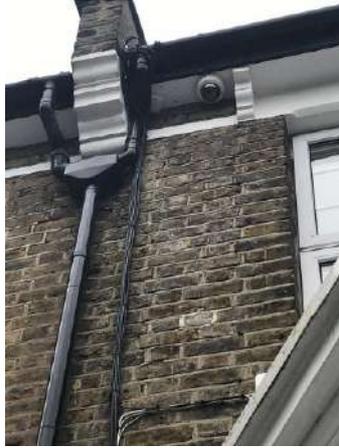
On the front elevation, the rainwater gutters and downpipes are formed from modern plastic. These appear to be in reasonable order and condition. The drain to the bay window roof is all old lead pipe dressed through the wall into a hopper head. This is in fair condition but of some considerable age and will need to be replaced within the next five years and approximate cost of £200.

Photo 13 - Front rainwater goods

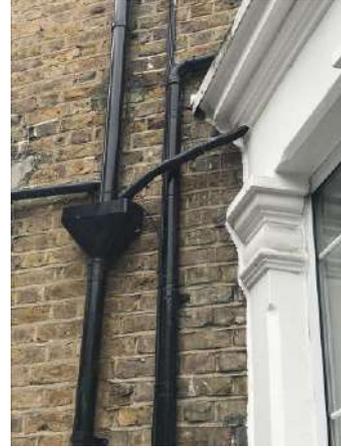
Photo 14 - Metal pipe

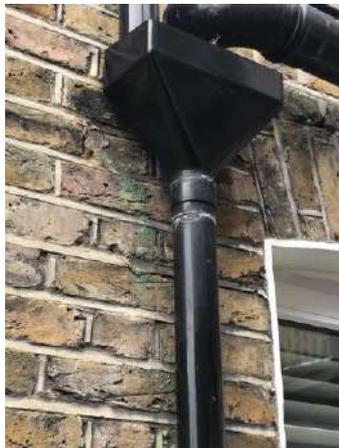
To the rear elevation the rainwater gutters and downpipes are plastic and were in reasonable condition. The joint to the hopper head on the flank wall shows staining and requires minor attention.

Photo 15 - Leaking joint

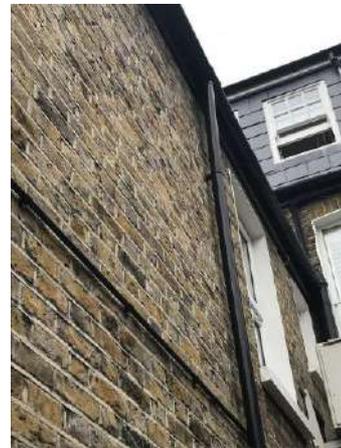
Photo 16 - Rear rainwatergoods

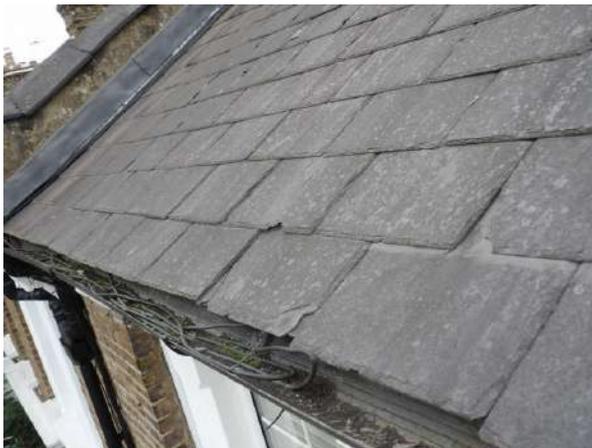
Some of the gutters are partially blocked with wires and cables and should be cleared in the immediate term to prevent any overflow.

Photo 17 - Blocked gutter

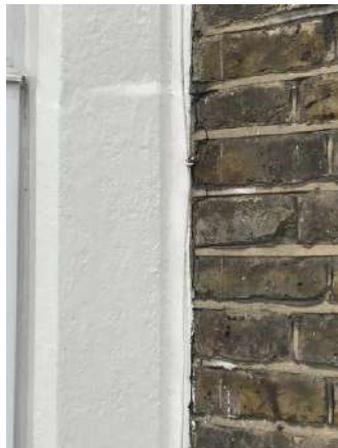
To the front elevation the bay window is reasonably flush and tight against the wall and showed no signs of major movement. The bay is weathered with some minor cracking and is in reasonable order and condition. To the right hand side there is a slightly open joint, this is of some age and is not considered significant, but will require repair and re-pointing immediately at a cost of approximately £250.

Photo 18 - Minor movement to bay window

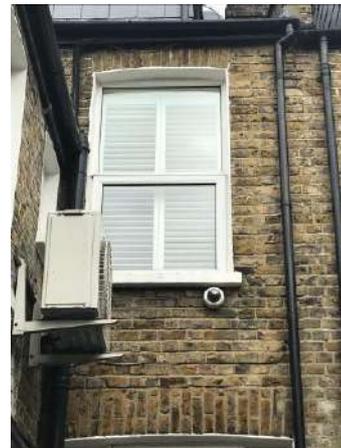
The rear elevations are formed from stock brickwork. The main wall was straight and in acceptable condition. The flank wall has a slight and minor bow in the brickwork at first floor level but this was not significant.

Photo 19 - Rear wall main building

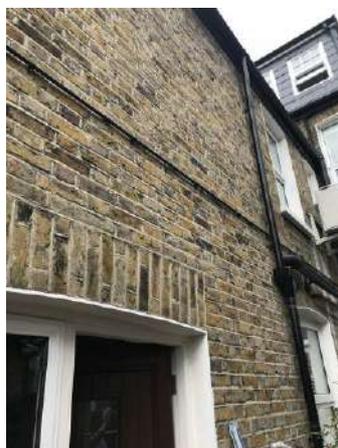
Photo 20 - Flank wall to rear elevation

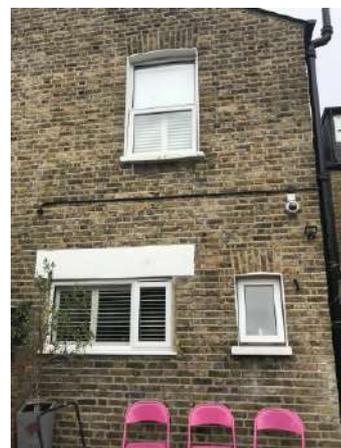
The rear wall of the rear addition was also straight and in acceptable condition

Photo 21 - Rear wall rear addition

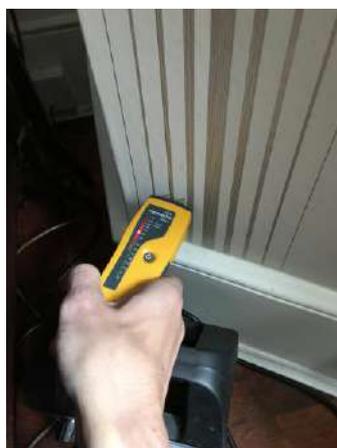
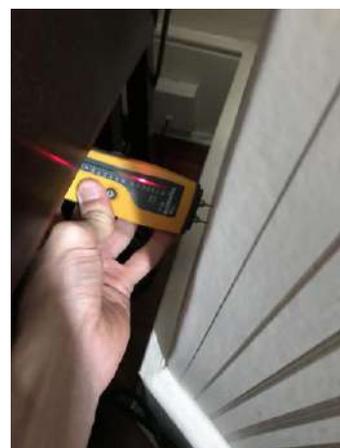
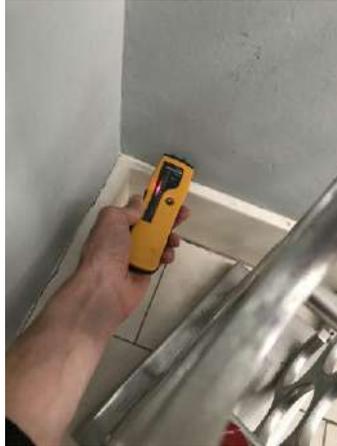
High damp meter readings were found on the front wall of the living room to the right hand side of the bay window. This is likely due to water ingress from the external crack crack at the junction of the bay window and main wall.

Further high readings were found towards the front of the kitchen on the flank wall, likely caused in part by the leaking air conditioning unit affixed to the flank wall externally at high level.

We suspect this is an isolated breakdown of the DPC and recommend that specialist contractors are asked to inspect and quote for rectification. We anticipate that this will cost approximately £1,000.

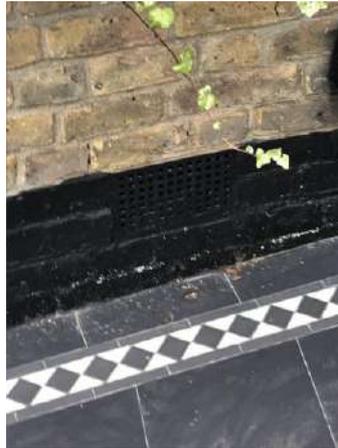
We observed adequate ventilation to the front elevation. No ventilation was noted to the rear walls and we recommend that additional vents are inserted.

Photo 25 - Sub floor vents to front

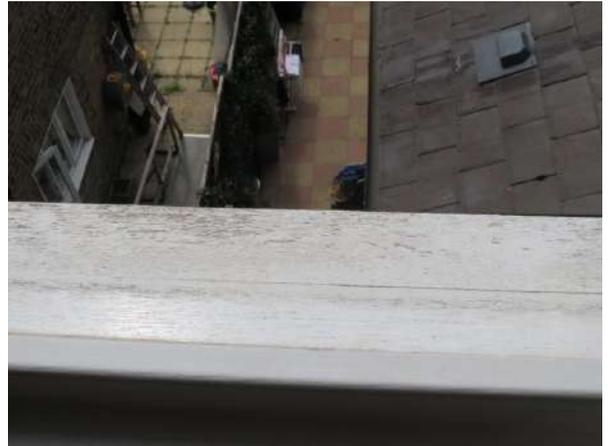
The windows to the second floor bedroom were timber framed sliding sash units that were in fair condition but they need to be redecorated in the immediate term.

Photo 27 - Timber cill requires painting

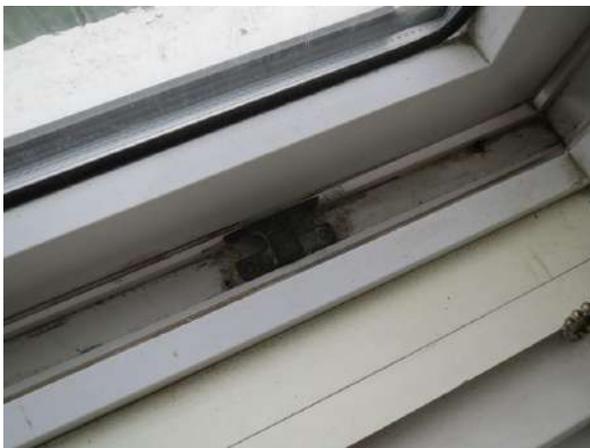
The windows typically appeared to be in good order and condition although slightly soiled at the time of inspection. The windows appear to open and close satisfactorily with exception of the first floor rear bedroom which was unable to be adequately closed and latched due to catching on the window catching on the locking mechanism of the window frame. This will require immediate attention and may require re-hanging by a specialist contractor at a cost of approximately £500.

Photo 28 - Defective window frame

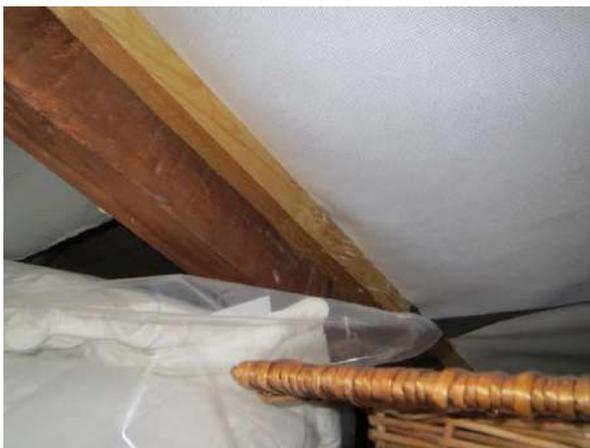
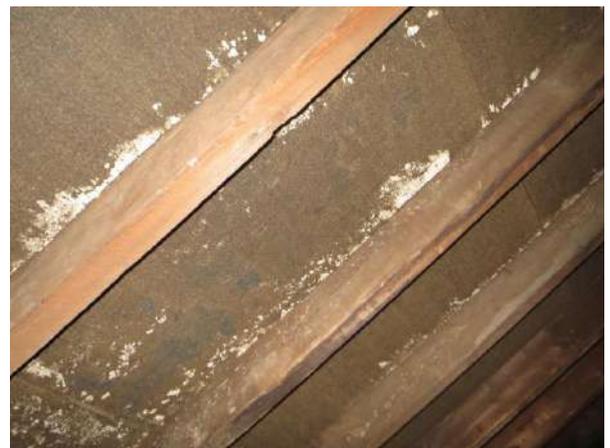
We noted no ventilation to the roof structure and this has given rise to condensation which has stained the underside of the sarking felt. The combination of poor ventilation and of moisture content (whether caused by condensation or by water ingress) provides ideal conditions for the onset of fungal decay such as dry rot. This is a serious timber destroying fungus which is usually costly to eradicate.

Photo 38 - Front eaves

Photo 39 - Rear addition roof showing

Ventilation must be provided at a cost of approximately £800.

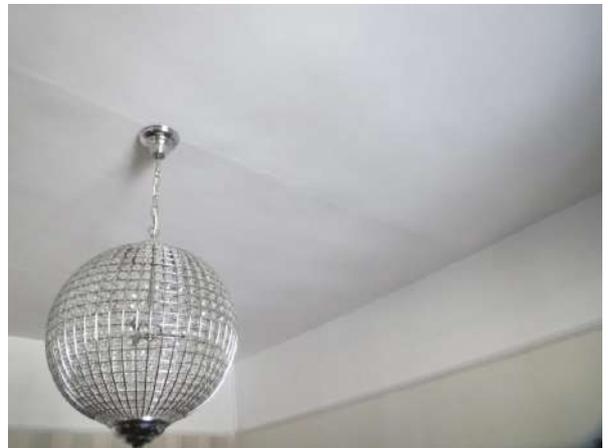
The ceilings and plaster finishes were found to be in satisfactory condition throughout the property with the exception of some minor shrinkage cracking which will require localised filling and redecoration.

Photo 41 - Cracked ceiling

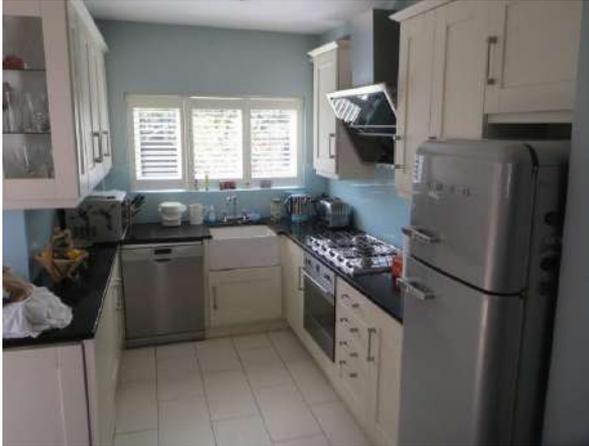
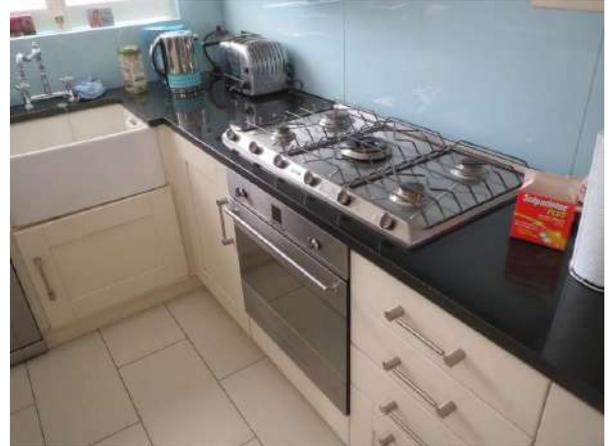
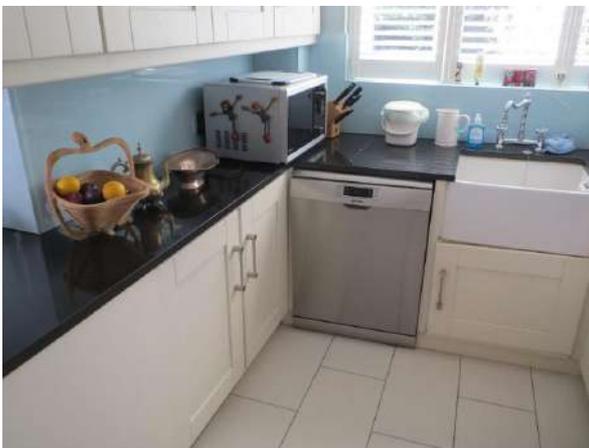
The kitchen fittings are modern and in satisfactory condition however the door below the sink is not attached properly and will need to be re attached. A number of the handles of the kitchen units are loose.

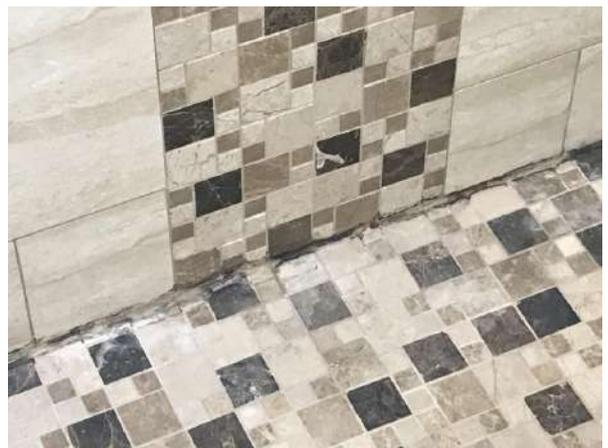
The first floor family bathroom contains a freestanding Perspex bath with mixer tap, wall hung wash basin, WC with concealed cistern, and a tiled shower stall. The base of the shower stall is badly formed and needs to be resealed to ensure that it is watertight. This must be done immediately.

Photo 55 - Poor seal

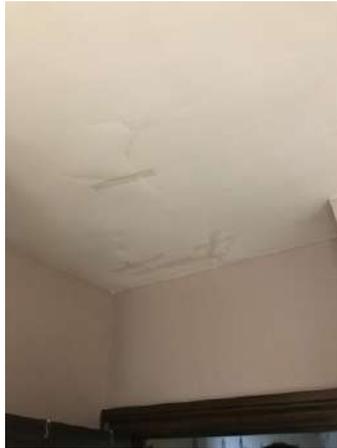
There is an area of stained and loose paper to the ceiling to the rear addition bedroom. This is caused by historic damp from the plumbing fittings in the loft above.

As noted above, there is a damp stained area to the ceiling of the rear addition bedroom. This was caused by leaking pipes to the plumbing above. The area was tested with a damp meter but was dry.

Photo 58 - Damp patch to ceiling of rear addition

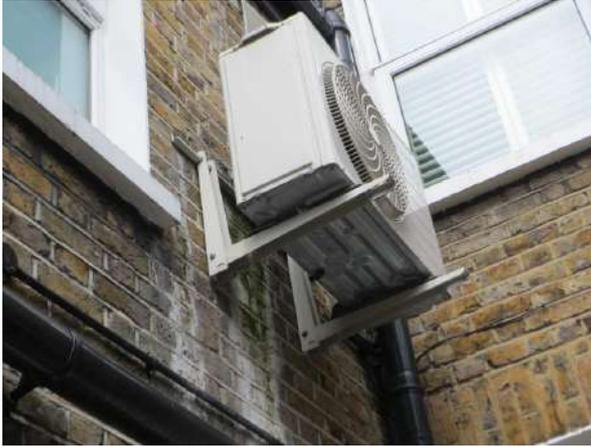
The building has the benefit of partial air conditioning and has a cassette unit fitted to the second floor bedroom. the condenser unit is fitted to the flank wall to the rear addition

Photo 63 - Air con unit
