**BUILDING SURVEY**

# Sample Street

David Toogood FRICS, IRRV,  
ACIArb

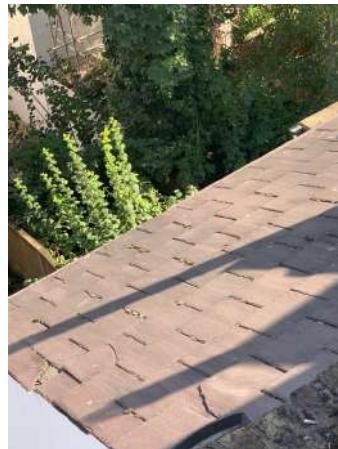
Photo 3 - Rear addition roof

The roof over the three storey rear addition is mono pitched and covered with natural slate. The slates are weathered and worn and a number were cracked or chipped. This roof covering has a life expectancy in the medium term only, 5 - 10 years, following which it will need to be recovered at an approximate cost of £3000.

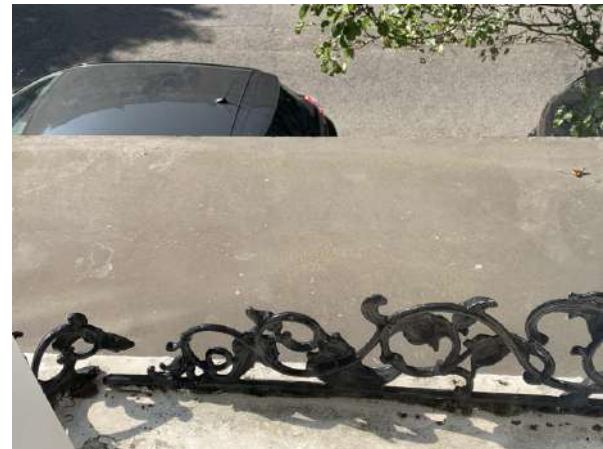
Photo 4 - Porch roof

The roof over the front entrance porch is flat and has been covered with what appears to be a bituminous felt. This is relatively new and was found to be in good condition.

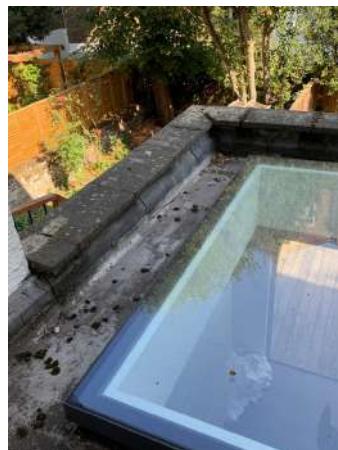
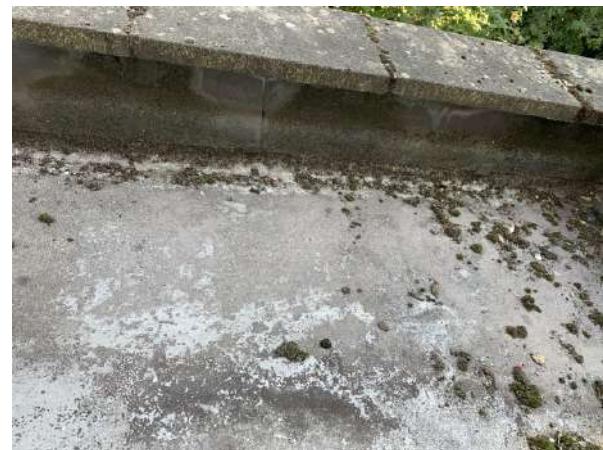
Photo 5 - Rear extension roof

The roof over the single storey rear extension is flat and has been covered with asphalt which was painted over with a heat reflective material. This is now badly worn and weathered and the asphalt itself is creased in several places. Here again the asphalt covering will need to be recovered in the medium term at an approximate cost of £8000.

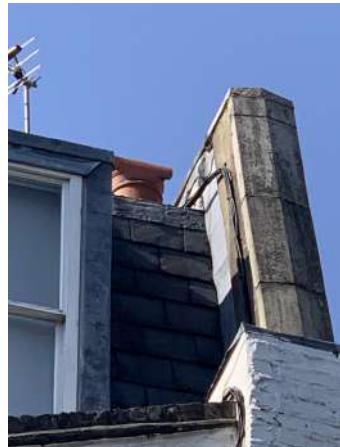
Photo 7

and brick on edge capping. The brick on edge is porous and hosting a thriving moss growth. The parapet is in reasonable condition but we recommend that the moss growth is cleaned off the parapet as soon as possible.

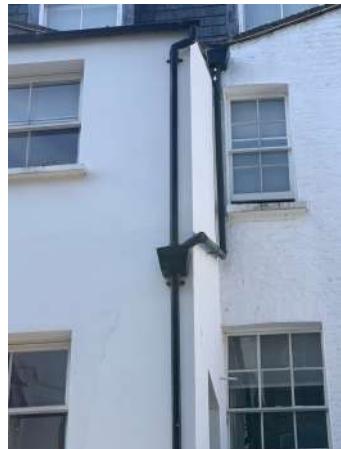
Photo 8 - Plastic rainwater goods

On the rear elevation, the rainwater downpipes and gutters are formed from modern plasticware. These were in relatively reasonable order and condition. The gutters to the rear addition was slightly blocked with debris and detritus and this should be clear.

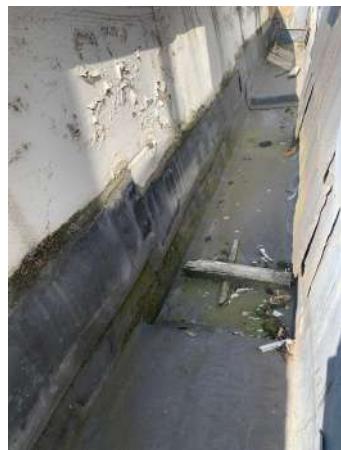
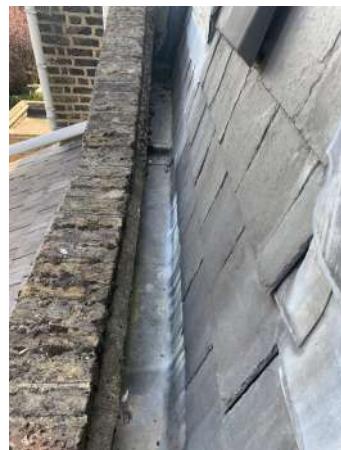
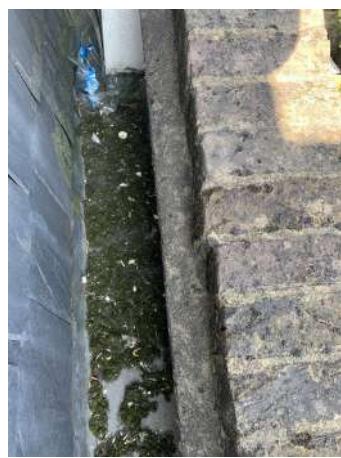
Photo 12 - Debris in box gutter

At front and rear behind the parapet walls are metal lined box gutters. The linings were noted to be in reasonable order and condition but the gutters are blocked partially with debris and detritus and this should be removed immediately. This type of gutter blocks easily and you should make a point of inspecting the gutters several times a year and clearing any obstructions.

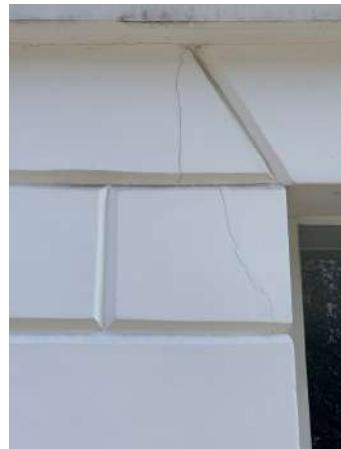
Photo 14 - Cracked render

On the front elevation, the ground floor render is in reasonable order and condition. Minor movement has caused some slight cracking to the left hand side of the top of the window frame and on the right hand side, there is a small section where the render is cracked and loose and this will require minor repair.

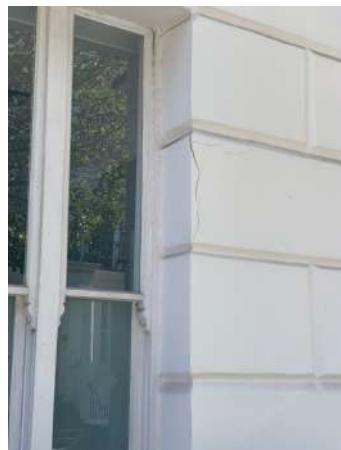
Photo 15 - Cracked render

The render covering to the lower right hand side of the front door opening is also cracked and loose and this too will need to be hacked off and re-rendered. A crack was noted extending upwards from the first floor right hand window to the cill above. These cracks are not considered to be of any major significance and are likely to be caused by minor movement in the building generally.

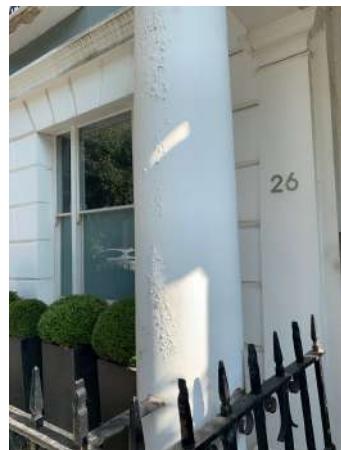
Photo 16 - Damp affected render to columns

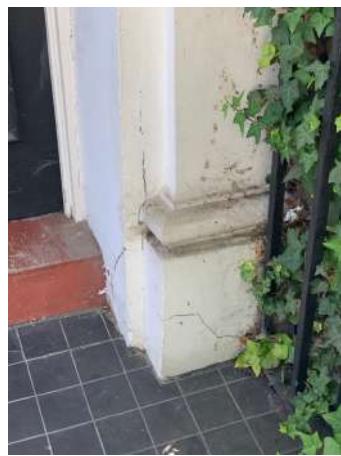
Photo 17 - Cracked render

The render at first and second floor levels is in good condition. Here again, minor signs of movement were noted with a crack extending from the underside of the cill to the first floor left hand window to the cornice. This was not considered significant.

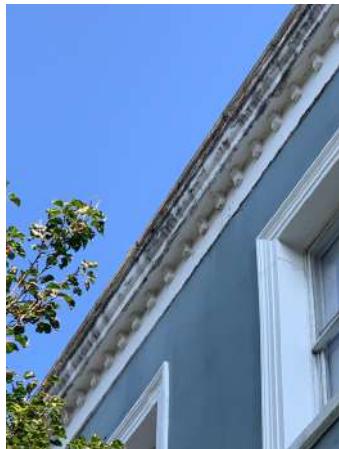
Photo 19 - Cornice

At higher levels, the cornice extends across the full width of the balcony above second floor level. The cornice is in poor condition. We recommend that this is hacked off and reformed at an approximate cost of £4,000. We further recommend that the upper section of the cornice is dressed with a lead cloak to prevent damp penetration. This is likely to cost approximately £2000.

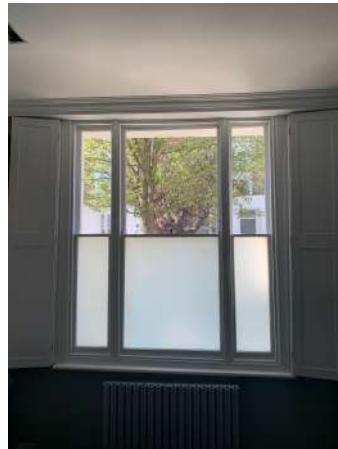
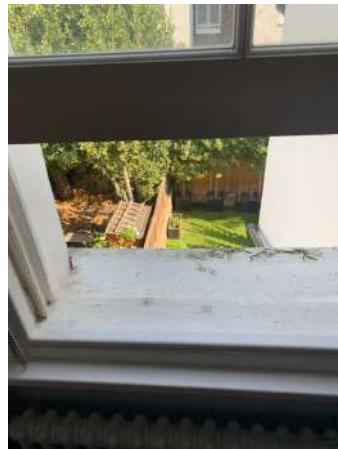
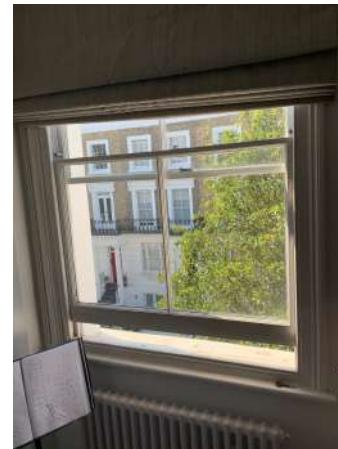
Photo 23 - Typical window

These were in fair condition only and were found to be either stiff and awkward to operate, or loosen draughty.. Easing and adjusting is required at a cost of approximately £2,000.

The windows generally are low quality and badly weathered and we would recommend that you consider replacing them in the medium term with double glazed units. This is likely to cost £25 - 30,000.

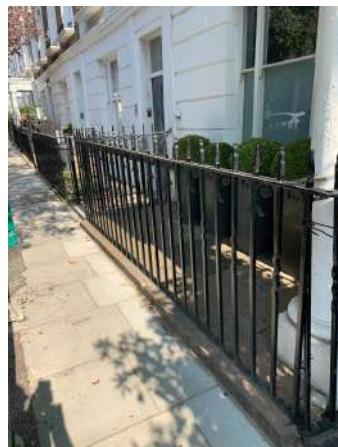
Photo 29 - Front boundary

The front boundary is formed from wrought iron railings which were in good condition. These extend down to form the left and right hand boundaries. The front gate has come off its hinges and is held in place with cable ties. This should be repaired.

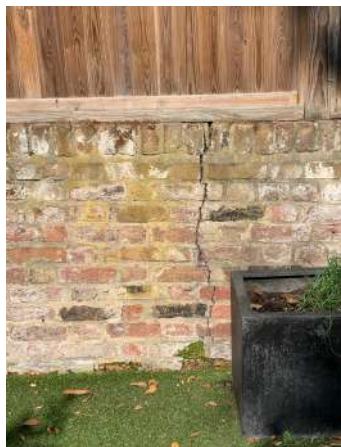
Photo 33 - Cracked brickwprk

The rear boundary on the left hand side is formed from solid brickwork and is of some considerable age. This is badly cracked adjacent to a bay tree growing in the left hand neighbours garden. The cracks should be cut out and should be stitched At a cost of approximately £600

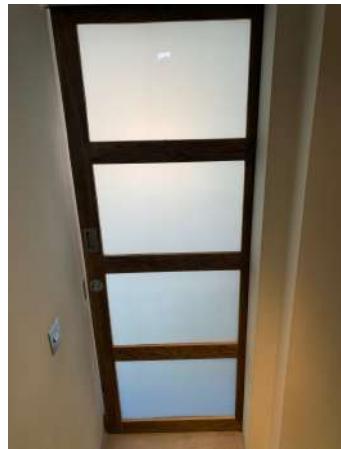
Photo 45 - Glazed door

The bathroom doors feature glazed panels and there is a large glazed panel to the wall in the first floor landing as a feature. The describe doors do not contain a Kitemark to indicate the glazing is safety glass and this could be a hazard should someone trip and fall into them. We recommend these are replaced with toughened safety glass.

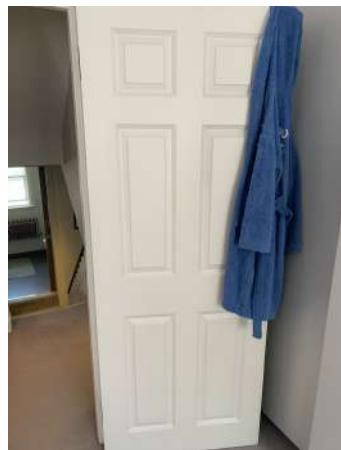
Photo 47 - Fire resisting door

The internal doors at ground first and second floor levels are of mixed quality but are not a fire resisting construction. Those at third floor level are fire resisting and this is probably been installed in order to comply with building regulations at the time the loft was converted. Although it is not a statutory requirement, we would recommend that you consider fitting fire doors to the kitchen, bedrooms and living rooms at ground first and second floor levels an approximate cost of £400 each.

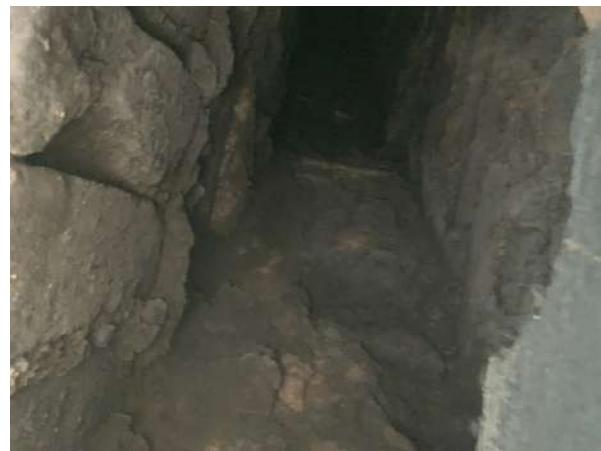
Without actual testing it is not possible to ascertain whether any of the chimney flues are in satisfactory working order. With age, the lining of the flues can deteriorate and this can allow fumes to re-enter the building at a higher level if fires are lit. It is considered safer to arrange for all flues that are to be used to be fully lined. The chimney should be inspected and swept by a chimney sweep annually and before first use. Any repairs identified should be undertaken immediately.

Photo 61 - Unlined flue
