**BUILDING SURVEY**

**1 Smith Road, London,  
SW6 4UR**

Example Report - Level 3  
Building Survey

Monday 5th January 2026

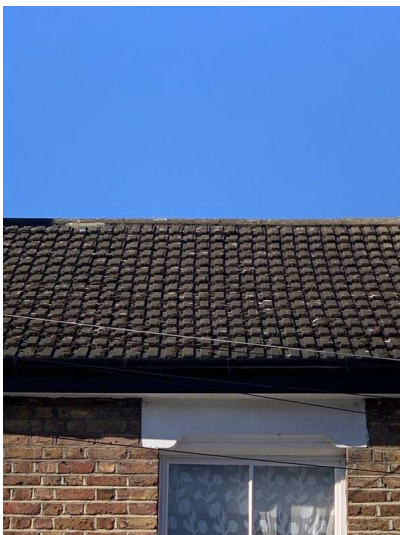
The rear roof slope could only be seen in part on the left hand side. This was similar to the front roof slope and was also in good order and condition apart from moss growth that should be cleared.

Photo 3 - Main Roof

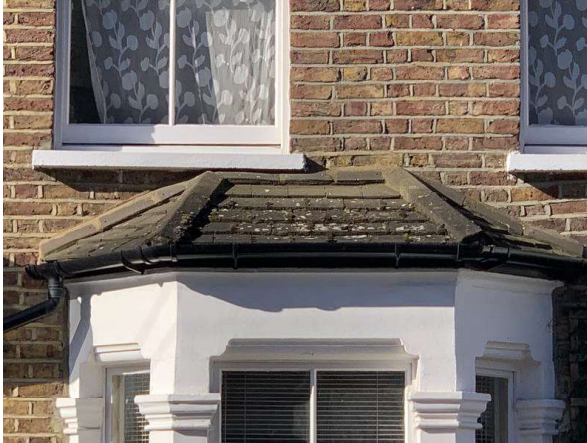
The tiling is in good condition but the joint with the front wall is formed from a sand / cement fillet. this is in good condition but will crack and allow water penetration in the medium term. It should be replaced with a metal flashing and soaker system at a cost of approximately £500.

Photo 4 - Roof over bay window

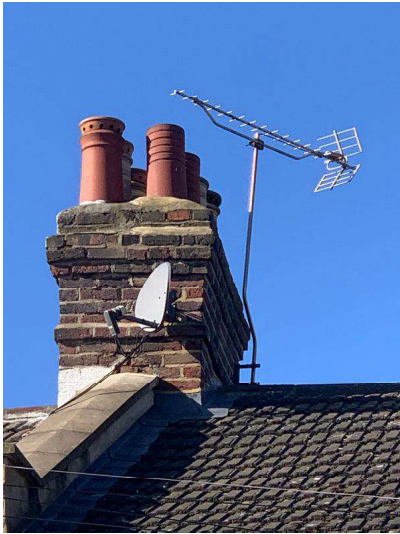
The stack is inevitably weathered but is otherwise in satisfactory order and condition.

Photo 5 - Chimney Stack

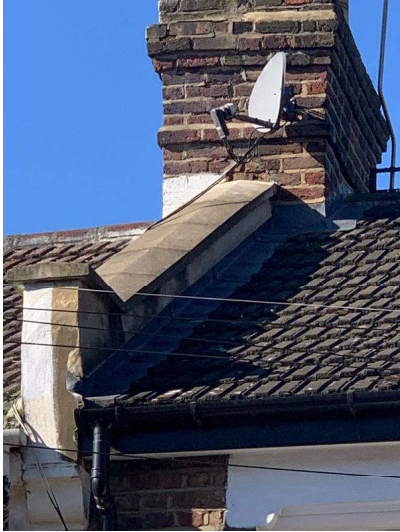
On the left hand side, the parapet wall is formed from solid masonry, rendered and capped with an oversailing coping stone course. This was in good condition.

Photo 6 - Parapet wall: left hand side

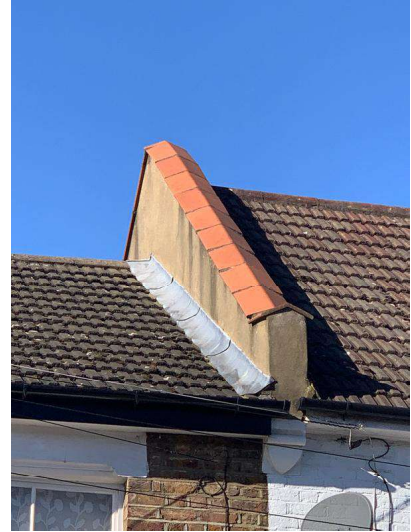
On the right hand side, the parapet wall is higher than on the left, also formed from masonry which has been rendered and capped with bonnet tiles. This was also in good condition.

Photo 7 - Parapet wall: Right hand side

Where the two parapet walls meet, the pitched roof covering, the joint has been sealed with a metal flashing. On the left hand side, this is better formed than that on the right, which is relatively loose and has clearly been laid over a sand cement fillet. This is effective at the present time but is unlikely to remain so for any more than the short term and this will need to be replaced at an approximate cost of £600.

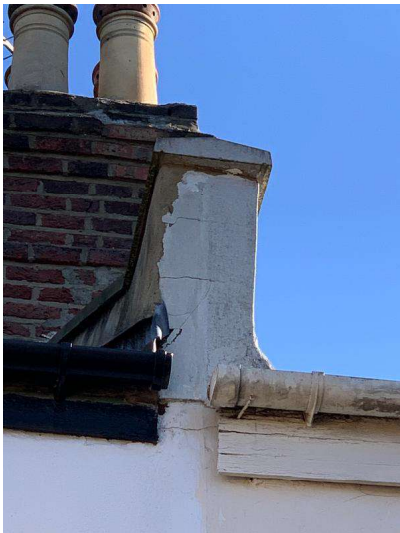
The parapet wall on the rear left hand side is similarly constructed to that on the front and this was also in reasonable condition.

Photo 8 - Parapet wall: Rear left

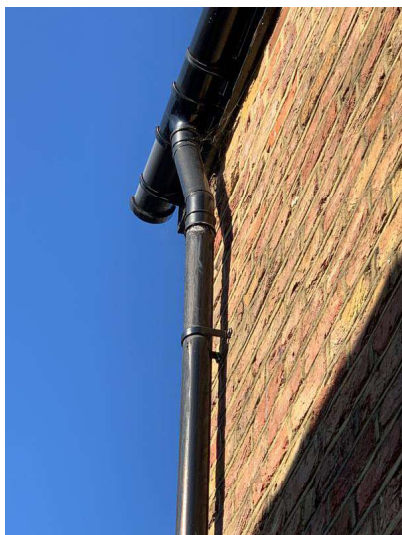
On the rear of the property, the rainwater gutters and downpipes are also formed from modern plastic. These are not new but were in reasonably good condition, save for the rear downpipe which is displaced at high level and leaking. This is a minor repair but should be executed immediately to prevent damp penetration.

Photo 11 - Misaligned downpipe

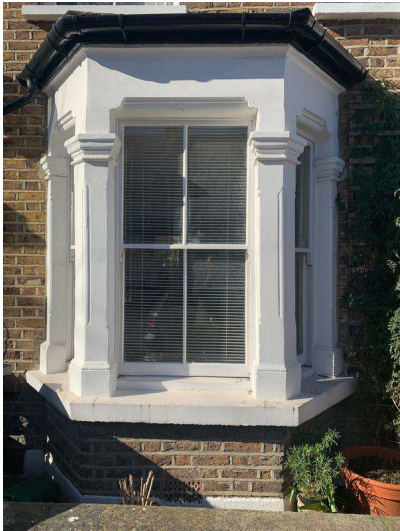
The front bay window is conventionally formed from a brick base with masonry reveals and lintels. The brickwork was cracked in the centre section and there were signs of movement by cracking on the left hand side and to a lesser degree, on the right hand side.

Photo 12 - Front bay

Bay windows such as these are often poorly founded on substandard foundations compared to the main building and such movement is frequent. In the case of the subject property, this movement is not significant enough to cause concern, but we would recommend that the cracks be raked out and filled to prevent water penetration and the bay window kept under observation. In the event that the foundations need to be strengthened, this will be likely to cost approximately £15,000.

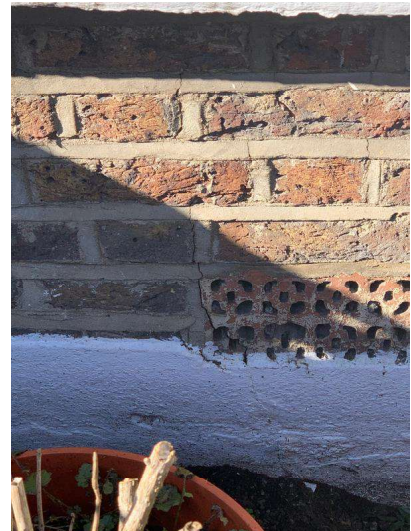
Photo 13 - Minor cracking

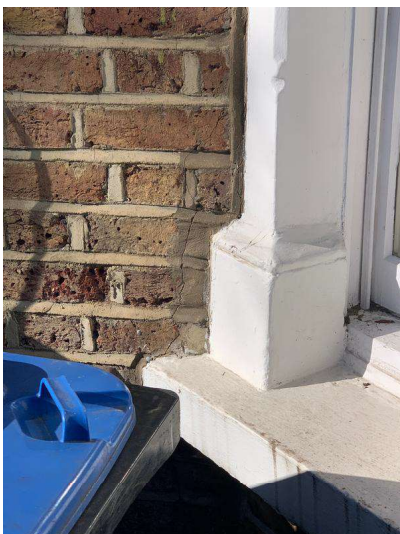
Photo 14 - Minor movement

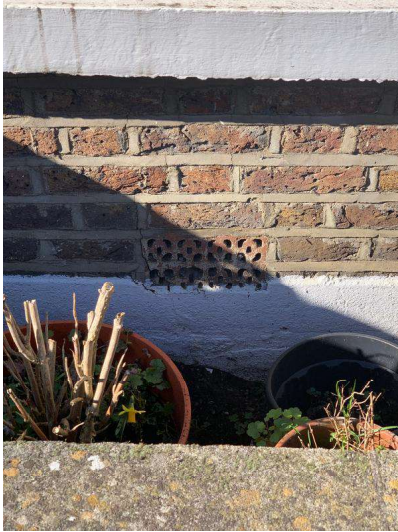
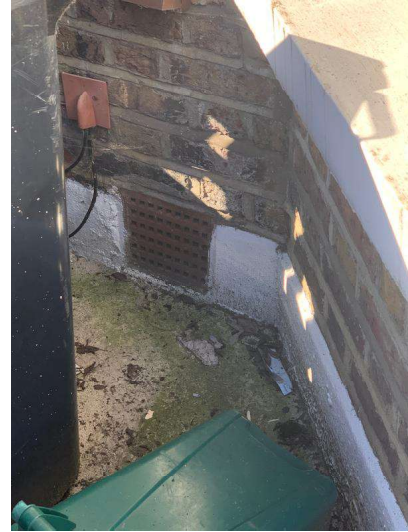
In order for there to be a sufficient through airflow and ventilation to the sub-floor there should be air vents to both the front and rear. However, it would appear that the vents to the rear have been covered over, likely as part of the past extension works. Good practice would have been to install ducting to extend the ventilation through the extension's solid floors, however this has not been undertaken. We would recommend ventilation is installed retrospectively to the suspended timber floors to the rear, however this may prove somewhat difficult. If not undertaken the floor timbers will be vulnerable to damp and decay.

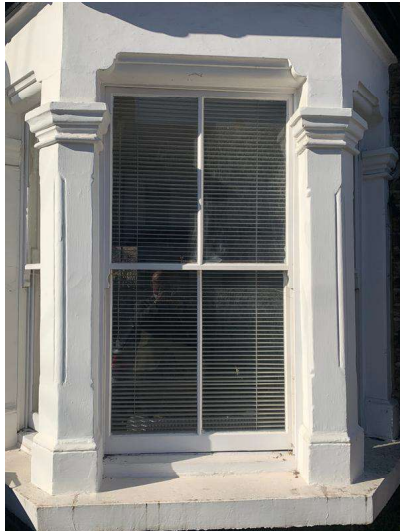
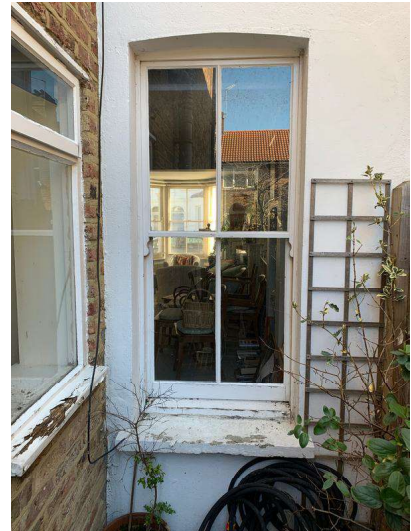
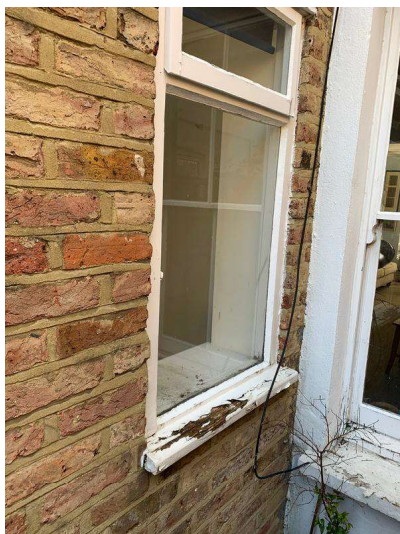
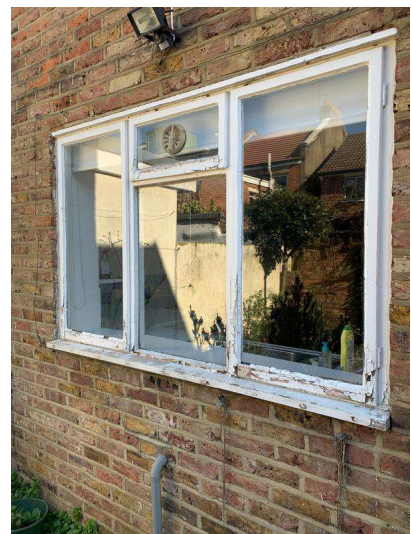
The majority of the windows in the property are formed from double hung, timber framed, sliding sash units. These were of poor quality and were generally either loose and draughty or stiff and awkward to operate. To the rear addition, poor quality factory made units have been used and these are also in poor condition.

Photo 22 - Bay window

Photo 23 - Dining room window

Photo 24 - Poor quality window with rotted sill

Photo 25 - Poor quality window

We would recommend that all of the windows in the property be replaced with better quality units and you may like to take the opportunity to replace these with double glazed units. This is likely to cost approximately £20,000.

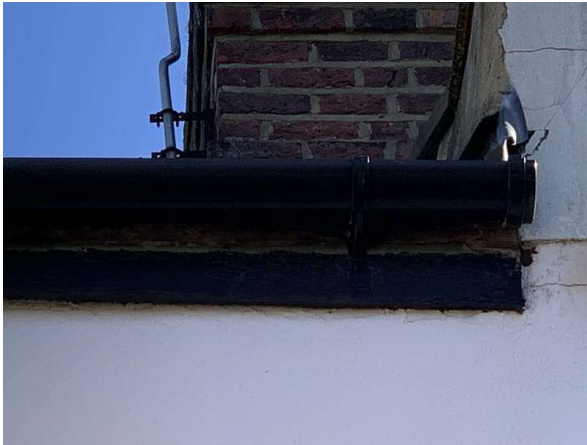
From our limited view from the ground, sections of the external joinery are badly weathered in areas and require repairs in the short term. Given their age and exposure, the external joinery will require regular maintenance and re-decoration to maintain its condition.

Photo 28 - Badly weathered fascia board

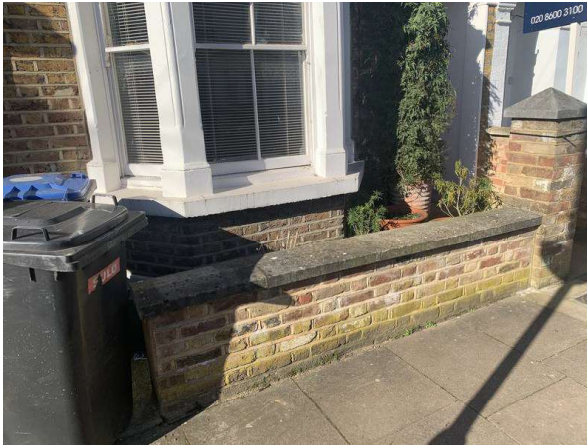
Photo 29 - Boundary wall

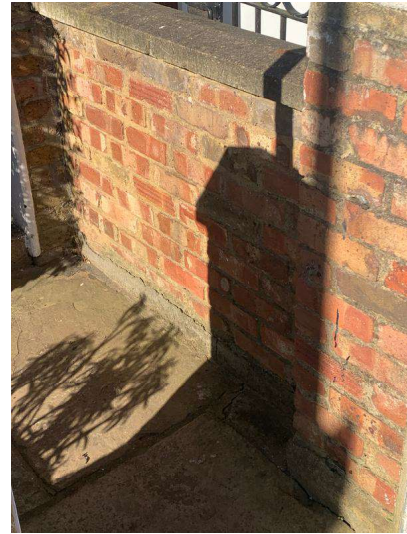
Photo 30 - Base of boundary wall

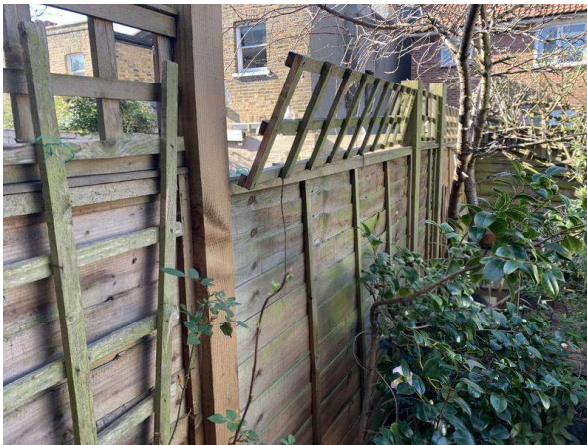
At the rear of the property, the left hand boundary is denoted by a timber boarded fence topped with a trellis. This was in reasonable condition but one of the trellis panels needs to be re-fixed. The rear right hand boundary is formed from a solid masonry wall, rendered, and the flank wall of the adjoining owners single storey rear addition. The render is weathered in places and minor filling is required.

Photo 31 - Left hand boundary fence

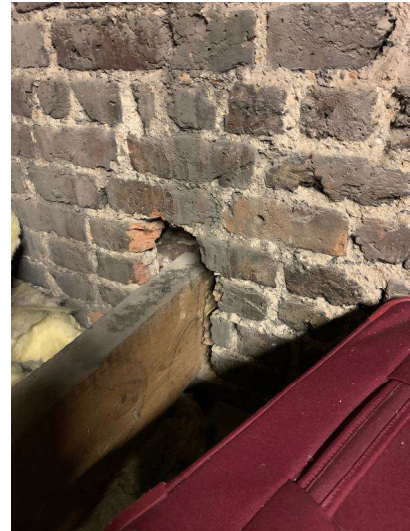
The purlins are built into the party walls on left and right hand sides but the hole into which they are inserted has not been filled. These should be filled now.

Photo 35 - Hole requiring filling

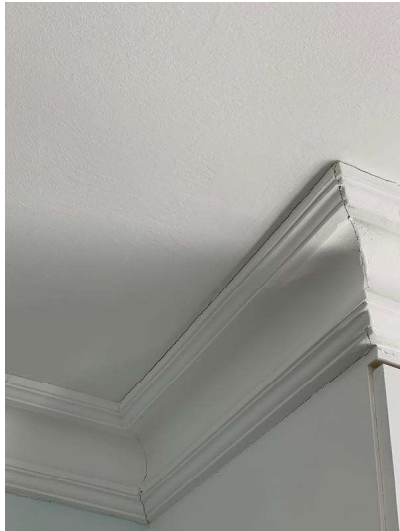
Photo 40 - Shrinkage cracking to coving

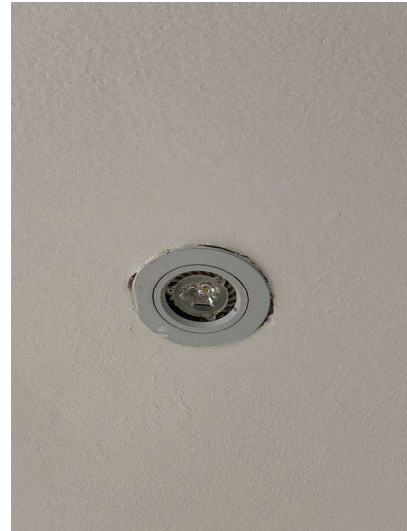
Photo 41 - Poor finish around spotlights

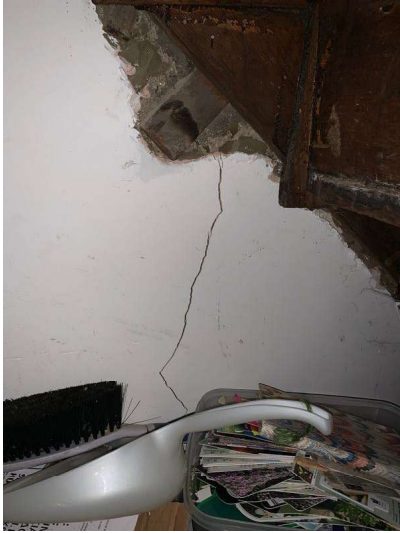
A large crack is visible in the cupboard under the stairs. This crack is caused by movement in the party wall at the junction of the main building and the rear addition. This is due to the failure to build in an expansion joint during original construction. This defect is common in buildings of this age and is not considered to be a serious defect. The crack has been repaired where it originally extended towards the head of the staircase. The crack should be cut out and be re-plastered when next re-decorating. The crack can be expected to re-appear.

Photo 42 - Under stairs: large crack

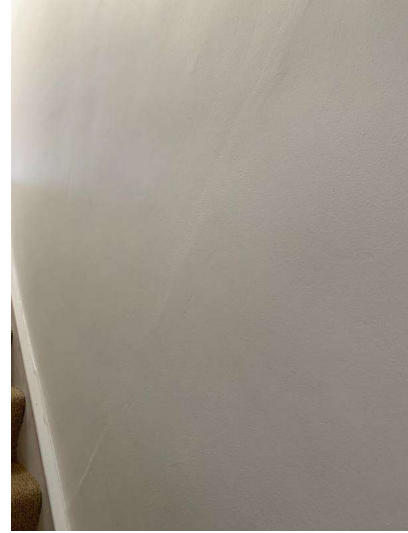
Photo 43 - Crack repaired and redecorated

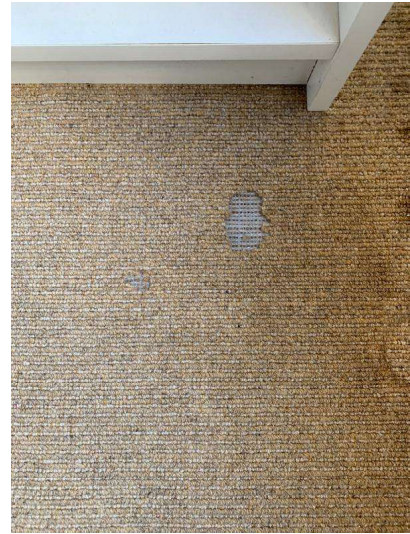
We noted that there is some damage to the carpet in certain areas which may indicate the presence of carpet moths. You should ensure that this is treated prior to laying any new carpets to in the property.

Photo 49 - Signs of Carpet Moth

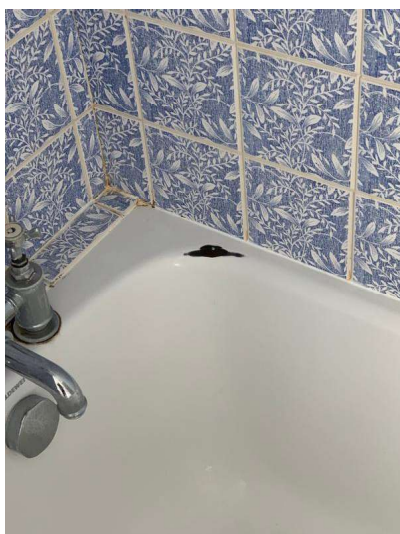
This bathroom contains a white suite consisting of an acrylic bath with mixer tap and a separate thermostatically controlled shower discharging over the bath, a WC with concealed cistern and a wall hung ceramic wash basin. The bath is damaged, in that the enamel is badly chipped on the rear left hand corner.

Photo 59 - Damage to bath

The fittings are generally low quality, low standard units and we would recommend that these are replaced.

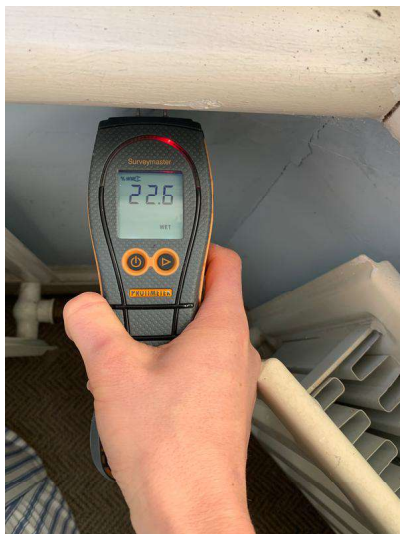
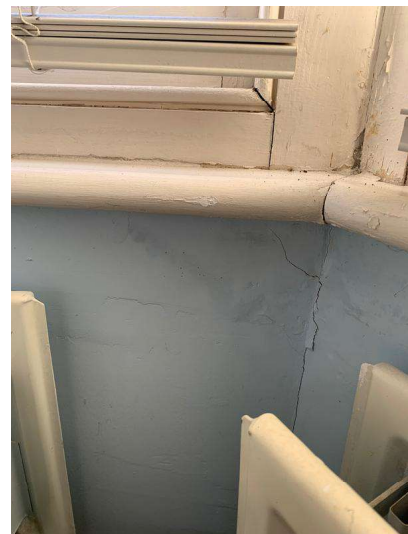
High damp meter readings were recorded under the bay window on the ground floor and under the window in the first floor bedroom. It is likely that this is caused by the poor

condition of the windows themselves (see the 'windows' section of this report) which are allowing water to penetrate the structure. Once the windows are replaced you should monitor these areas. Should the problem persist we recommend that a PCA qualified damp and timber specialist is instructed to carry out further investigation of the walls and the timbers in contact with them. Quotes should be obtained for the remedial works necessary.

Photo 63 - Front bay window

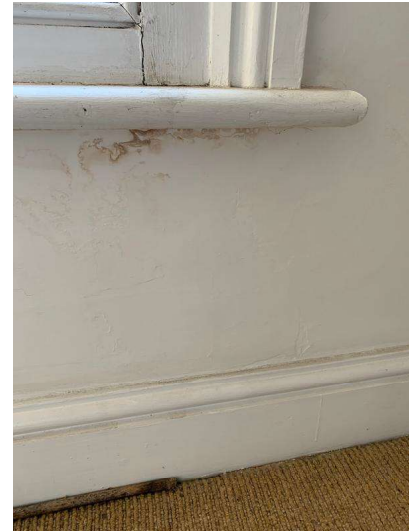
Photo 66 - First floor bedroom
