**BUILDING SURVEY**

# Example Property

David Toogood FRICS, IRRV,  
ACI Arb

Saturday 28th July 2018

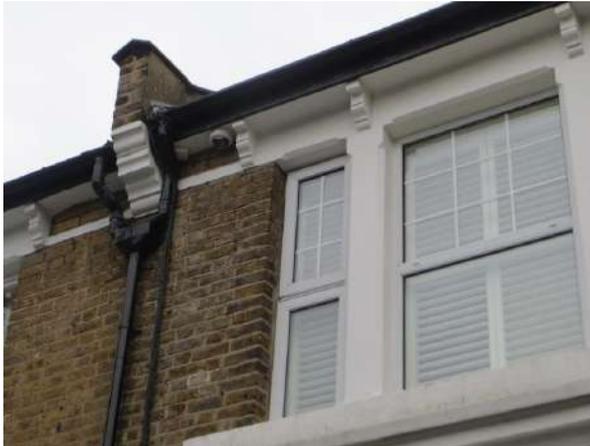
The windows to the second floor bedroom were timber framed sliding sash units that were in fair condition but they need to be redecorated in the immediate term.

Photo 26 - Typical window

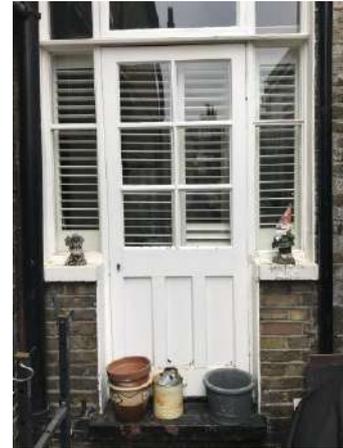
The rear door to the dining room is formed from timber with single-glazed panels. This was in reasonable condition.

Photo 30 - Dining room door

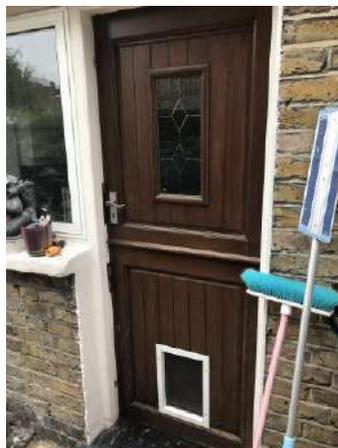
The kitchen door is a recent " stable " door arrangement and was in good order.

Photo 31 - Kitchen door

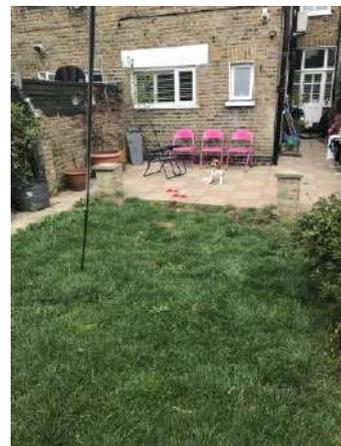
The rear garden is laid to paving stones for the most part which were in good order and condition & reasonably level. The lawn area is poor.

Photo 37 - Rear garden

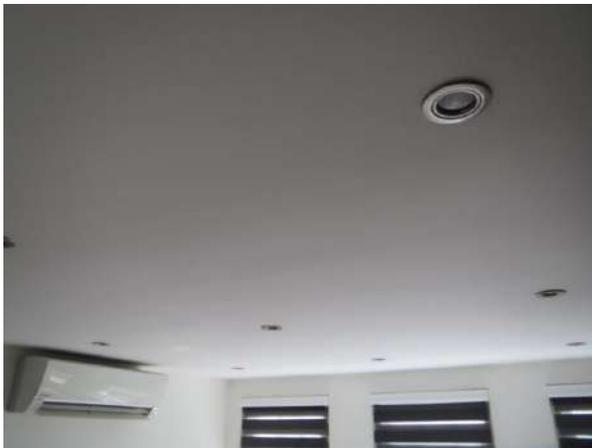
There is an area of stained and loose paper to the ceiling to the rear addition bedroom. This is caused by historic damp from the plumbing fittings in the loft above.

Photo 40 - Plasterboard ceiling

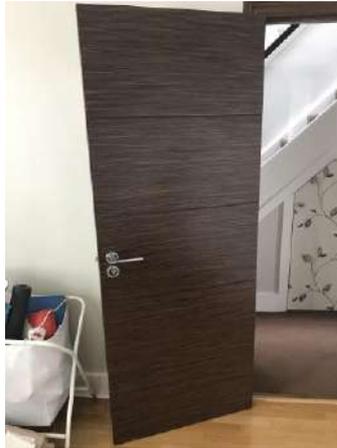
The doors have been replaced with modern units which were part glazed to the ground floor and fully panelled to the upper floors. These were in good condition but none of the doors appear of fire resisting construction and although it is not a statutory requirement, we would recommend that you consider fitting fire doors to the kitchen, bedrooms and living room at an approximate cost of £400 each.

Photo 44 - Typical door

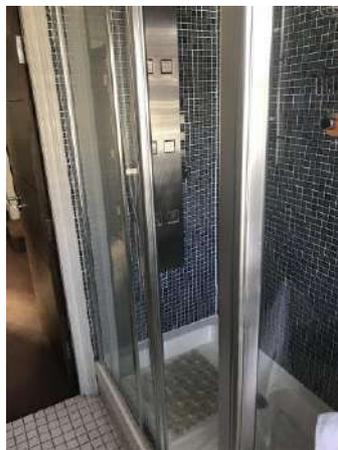
The first floor family shower room has a ceramic wash basin, WC with close coupled cistern and rectangular shower stall with resin base, glazed screens and multi directional shower fitting. These are in reasonable condition.

Photo 52 - First floor family shower room

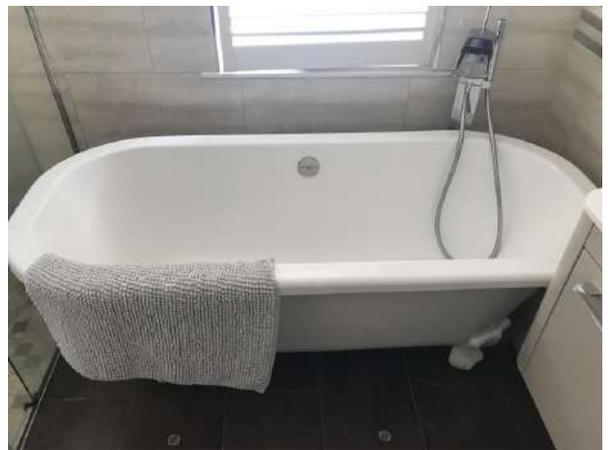
The first floor family bathroom contains a freestanding Perspex bath with mixer tap, wall hung wash basin, WC with concealed cistern, and a tiled shower stall. The base of the shower stall is badly formed and needs to be resealed to ensure that it is watertight. This must be done immediately.

Photo 53 - Family bathroom

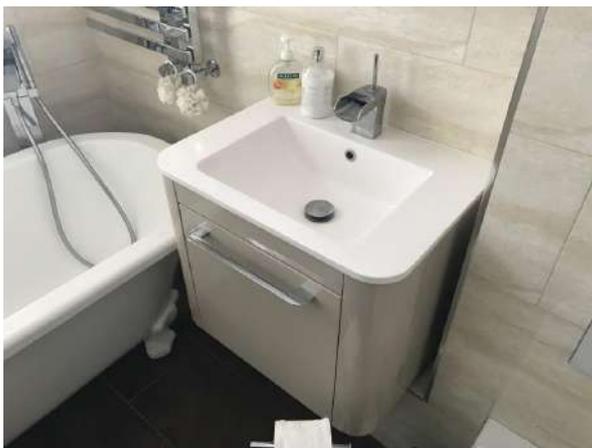
Photo 54 - Family bathroom

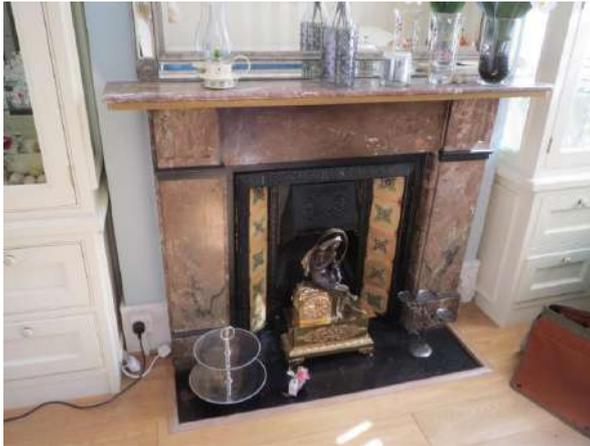
Photo 56

The living rooms and bedroom contain feature fireplaces with an open fire. The fireplaces appear to be in satisfactory condition however we cannot comment upon their working order.

If you wish to use the fireplaces the chimney flues should be correctly lined at an approximate cost of £1,500. Without actual testing it is not possible to ascertain whether any of the chimney flues are in satisfactory working order. With age, the lining of the flues can deteriorate and this can allow fumes to re-enter the building at a higher level if fires are lit. It is considered safer to arrange for all flues that are to be used to be fully lined.
