**BUILDING SURVEY**

# Sample Street

David Toogood FRICS, IRRV,  
ACIArb

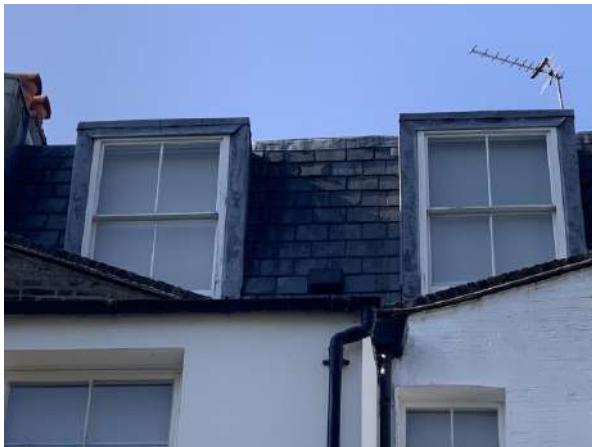
Photo 2 - Rear of main roof

The rear roof slope is a near vertical slate hung mansard with two lead clad dormer windows. The slate covering is in good order and condition.

No view of the flat, upper or crown roof could be obtained and we cannot advise on its condition.

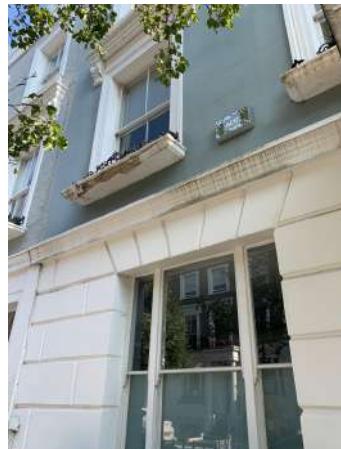
Photo 13 - Front elevation

On the front elevation, the ground floor render is in reasonable order and condition. Minor movement has caused some slight cracking to the left hand side of the top of the window frame and on the right hand side, there is a small section where the render is cracked and loose and this will require minor repair.

The render at first and second floor levels is in good condition. Here again, minor signs of movement were noted with a crack extending from the underside of the cill to the first floor left hand window to the cornice. This was not considered significant.

The window cill to the first floor left hand window is badly damaged and will need to be hacked off and be reformed.

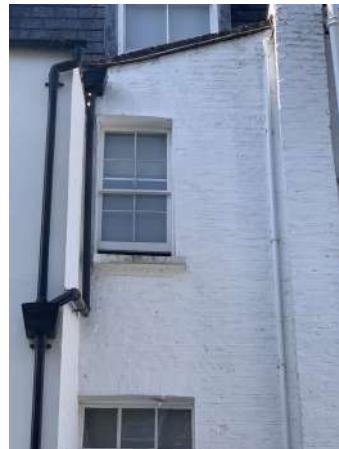
Photo 20 - Rear elevation main building

The rear wall was noted to be reasonably straight and true and no significant signs of defects were noted.

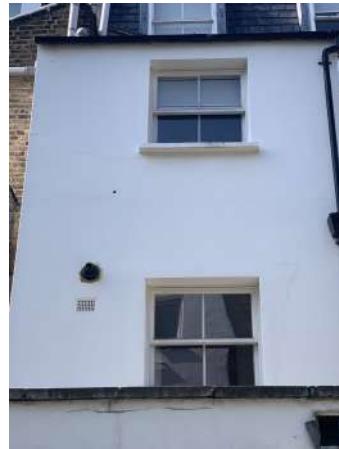
Photo 22 - Rear wall to rear addition

The flank and rear walls of the three storey rear addition were reasonably straight and true and showed no signs of any significant defects.

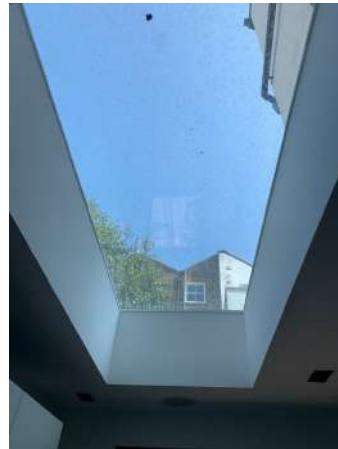
Photo 24 - Skylight

The property has the benefit of various skylights and these were found to be in good order where inspected.

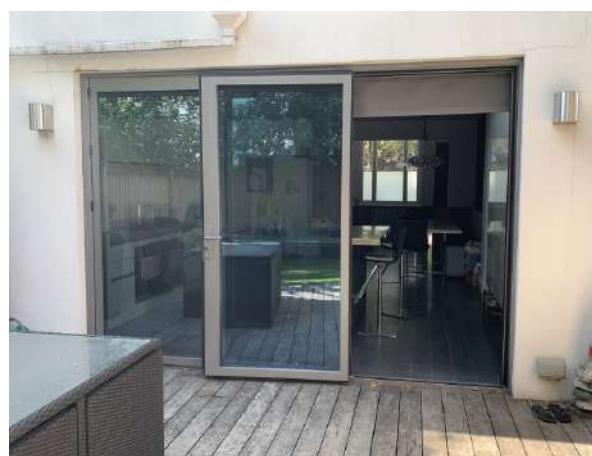
Photo 28 - Rear doors

The rear doors comprise metal framed double glazed bifold units that were in good order and condition.

You should ensure the junctions of the door frames and masonry is sealed and kept in good order. If the seals become cracked or damage then water penetration can occur in bad weather.

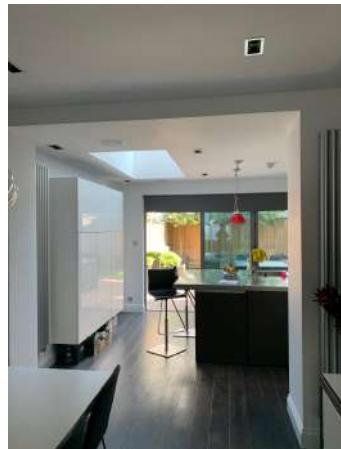
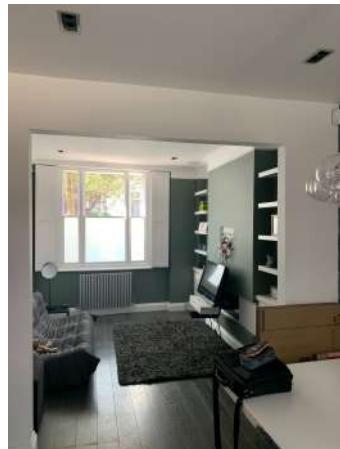
At ground floor level the original cross partitions between the living room and dining room, and the original external walls within the kitchen, have been removed to open up and adjoin the area. These partitions would have been load bearing and required insertion of a steel joists or beams to support the loads above. We could not open up the structure and cannot confirm that such a beam has been installed but we can say that there is no sign of any distress or distortion to the floor above to indicate that this was not the case. In the kitchen the original flank wall has been removed to open up the space and conjoin it with the side extension. This would have required the installation of robust steel beams to support the walls above. We could not inspect these beams and cannot comment on their condition except to say that we saw no sign of any distress or distortion to the structure above to suggest that the support provided is inadequate.

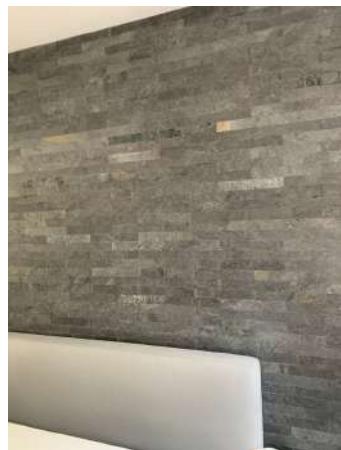
Photo 42 - Mock stone finish

The party wall to the dining room has had a mock stone finish applied purely for aesthetic purposes.

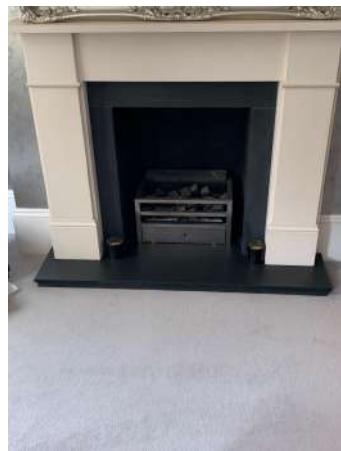
Photo 60 - Gas fire & fireplace

Without actual testing it is not possible to ascertain whether any of the chimney flues are in satisfactory working order. With age, the lining of the flues can deteriorate and this can allow fumes to re-enter the building at a higher level if fires are lit. It is considered safer to arrange for all flues that are to be used to be fully lined. The chimney should be inspected and swept by a chimney sweep annually and before first use. Any repairs identified should be undertaken immediately.

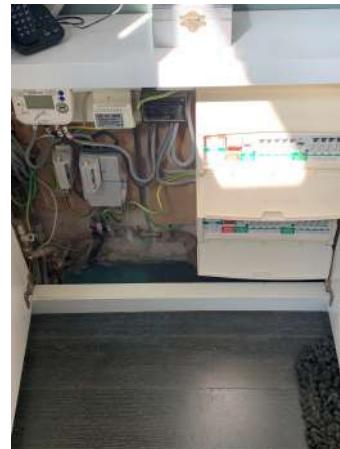
Photo 63 - Meter & fuseboard

You are advised that the electricity supply companies recommend that domestic wiring is tested every ten years or on change of ownership, whichever is sooner.

In the absence of a current electrical test certificate, we would advise you to employ the services of a qualified electrician to inspect and test the wiring and to provide you with a report on its condition together with a quotation for any improvement works found necessary.

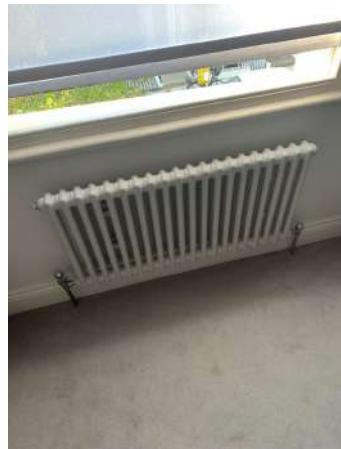
The heating system was not on at the time of our inspection but appeared in satisfactory condition with no visual defects apparent. We have not tested the system.

Photo 65 - Typical radiator

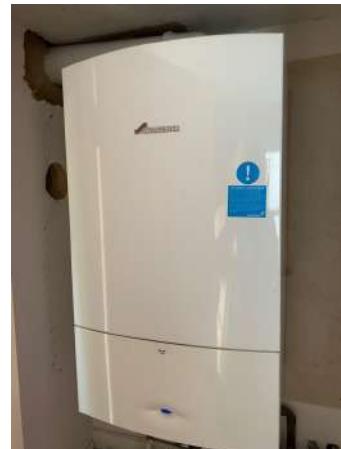
Photo 66 - Boiler

You can't always be sure when the appliances and pipework were last serviced and checked. The vendor should be able to provide you with a Gas Safety Record showing that a suitably qualified Gas Safe registered engineer has checked the gas installation pipework and appliances.

If they are unable to do this, you will need to contact a registered engineer to test and report on the system before you exchange. The engineer should be able to complete a record and provide it to the vendor so they can pass it onto you when you move into the property. The system should then be inspected annually.

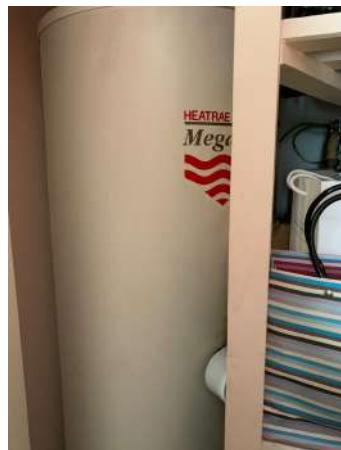
Photo 67 - Hot water cylinder
