**BUILDING SURVEY**

**1 Smith Road, London,  
SW6 4UR**

Example Report - Level 3  
Building Survey

Monday 5th January 2026

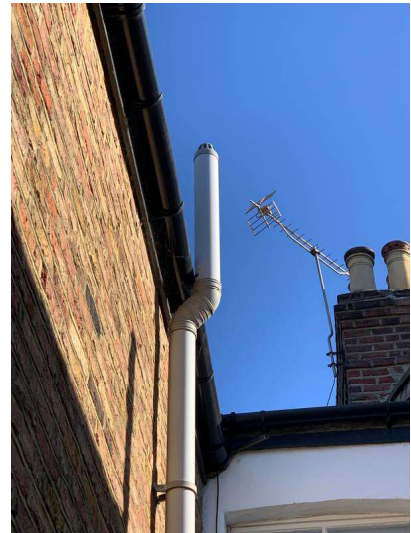
On the rear of the property, the rainwater gutters and downpipes are also formed from modern plastic. These are not new but were in reasonably good condition, save for the rear downpipe which is displaced at high level and leaking. This is a minor repair but should be executed immediately to prevent damp penetration.

Photo 10 - Gutter

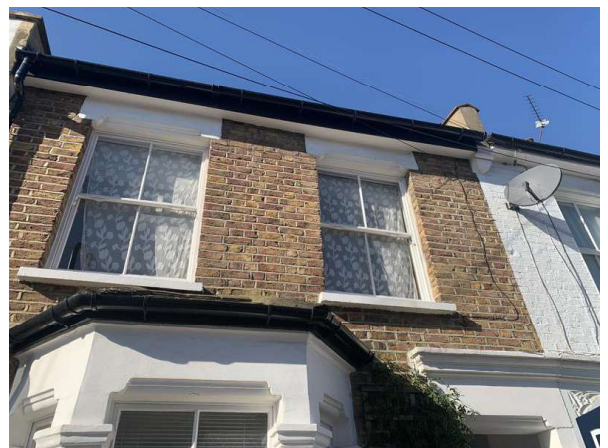
The front bay window is conventionally formed from a brick base with masonry reveals and lintels. The brickwork was cracked in the centre section and there were signs of movement by cracking on the left hand side and to a lesser degree, on the right hand side.

Bay windows such as these are often poorly founded on substandard foundations compared to the main building and such movement is frequent. In the case of the subject property, this movement is not significant enough to cause concern, but we would recommend that the cracks be raked out and filled to prevent water penetration and the bay window kept under observation. In the event that the foundations need to be strengthened, this will be likely to cost approximately £15,000.

Photo 15 - Front elevation

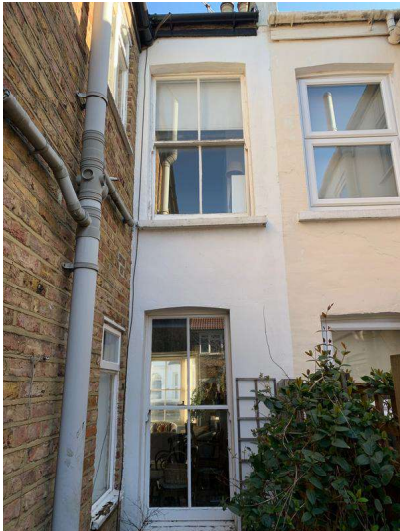
The rear wall to the main building has been fully rendered. This was straight and in reasonable order and condition.

Photo 16 - Rear elevation

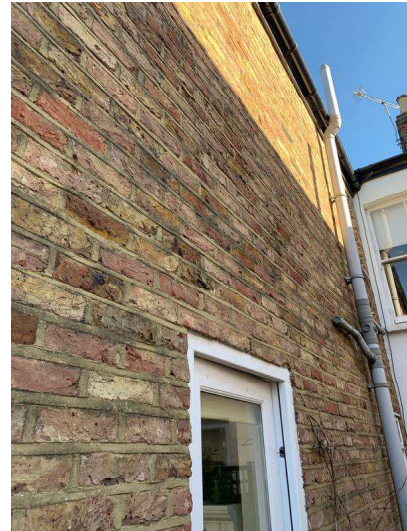
The brickwork to the flank and rear walls is fair faced. This was in reasonable order and condition with no significant defects noted.

Photo 17 - Flank wall

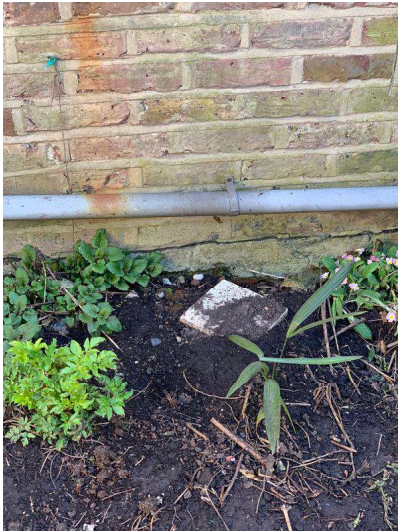
Photo 18 - Visible damp proof course to new rear addition.

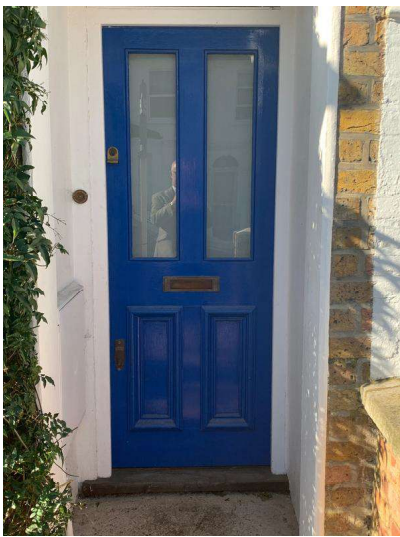
The main front entrance door is the original timber and glazed unit. This was in reasonable condition, fitting fairly well within the frame. The two glazed panels have been replaced with security glass and were in good order.

Photo 26 - Main front door

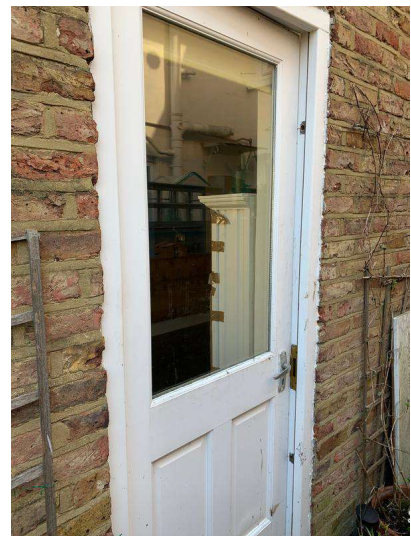
From our limited view from the ground, sections of the external joinery are badly weathered in areas and require repairs in the short term. Given their age and exposure, the external joinery will require regular maintenance and re-decoration to maintain its condition.

Photo 27 - Rear door

You should ensure the junctions of the door frames and masonry is sealed and kept in good order. If the seals become cracked or damaged then water penetration can occur in bad weather.

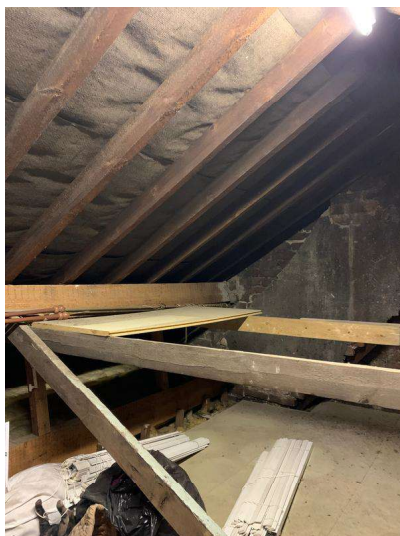
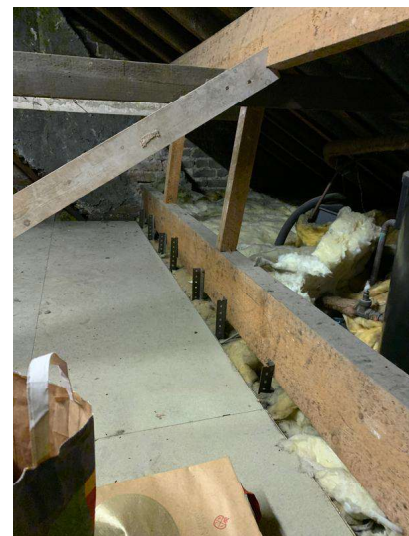
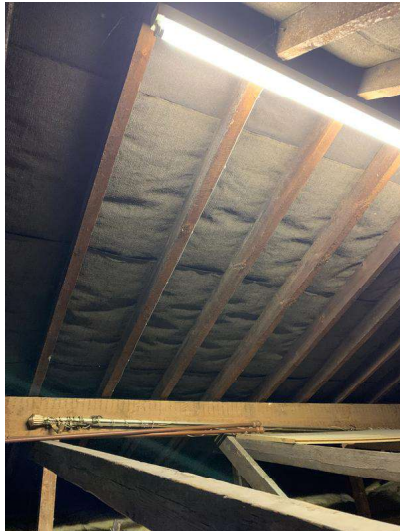
The purlins are built into the party walls on left and right hand sides but the hole into which they are inserted has not been filled. These should be filled now.

We noted no ventilation to the roof structure and this can give rise to condensation. The combination of poor ventilation and of moisture content (whether caused by condensation or by water ingress) provides ideal conditions for the onset of fungal decay such as dry rot. This is a serious timber destroying fungus which is usually costly to eradicate. Ventilation is therefore advisable although it is fair to say that it is frequently omitted.

Photo 32 - Roof structure

Photo 33 - Roof structure

Photo 34 - Roof structure

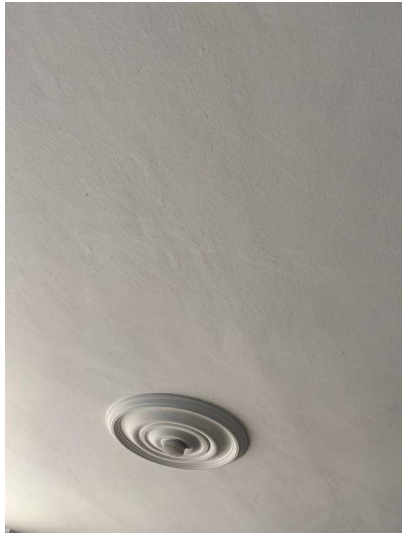
Cracking in plaster often occurs due to the general ageing of the material and loss of adhesion over time. On-going repairs will be necessary and the cracking may re-open from time to time.

The ceiling paper obstructed our inspection of the plaster finished and is often used to conceal defective plaster. If this is removed you may find that repairs and re-plastering is necessary.

Photo 36 - Living room: lath and plaster

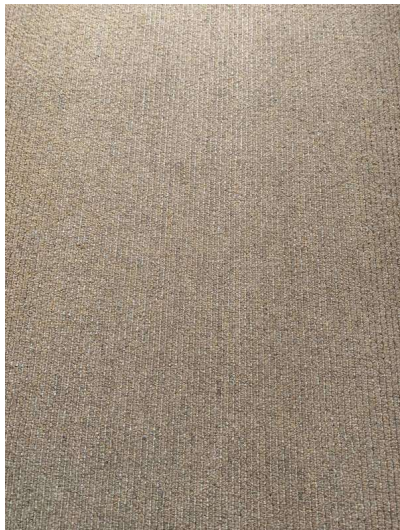
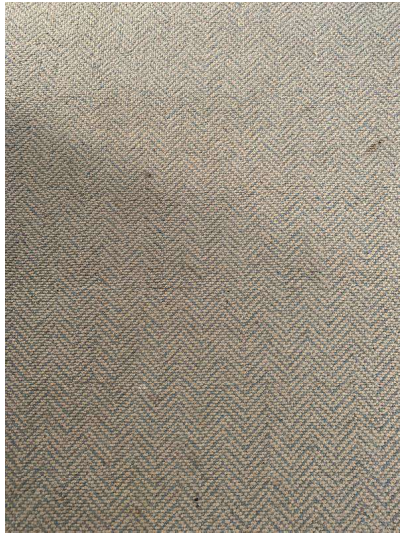
We noted that there is some damage to the carpet in certain areas which may indicate the presence of carpet moths. You should ensure that this is treated prior to laying any new carpets to in the property.

Photo 46 - Carpet

Photo 48 - Carpet

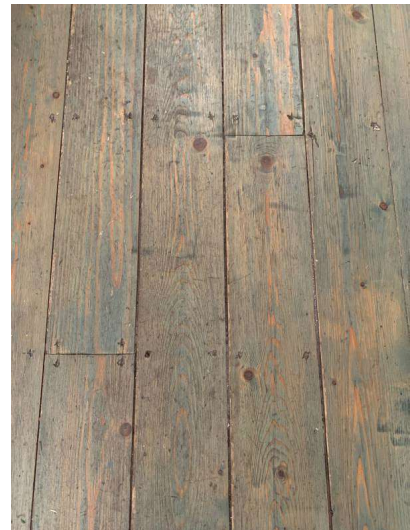
We did not find any signs of wood-boring beetle attack to the floor timbers, however given the age and location of the property it is inconceivable that it would have escaped the attentions of woodworm. Should an outbreak be discovered, localised treatment may be necessary.

Photo 47 - Treated floorboards

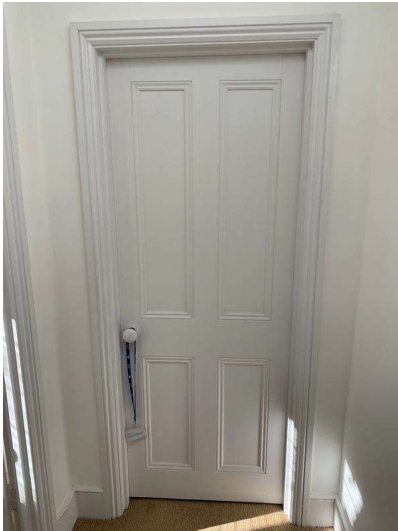
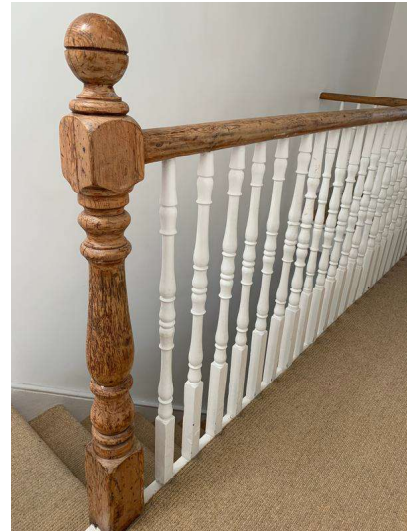
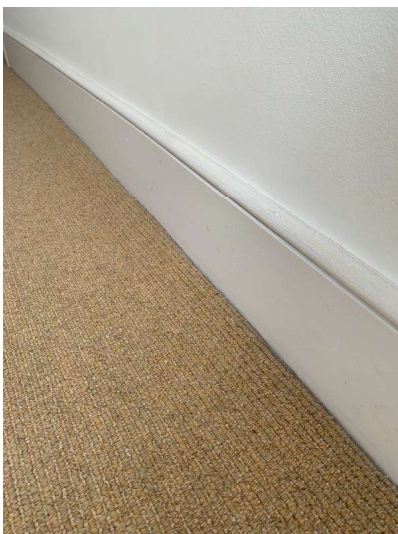
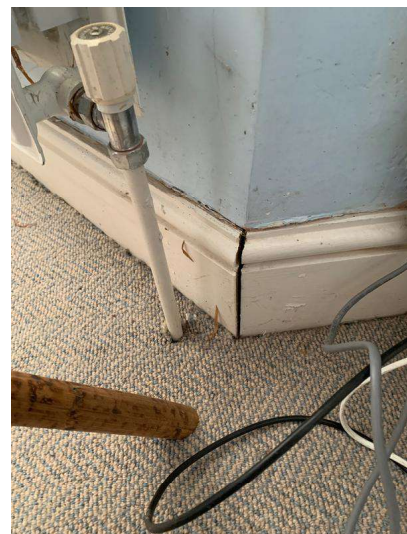
Much of the internal joinery is rather dated and worn and you may wish to upgrade this to your own taste in due course.

Photo 50 - Typical door

Photo 51 - Banister

Photo 52 - Skirting

Photo 53 - Skirting board front bay window

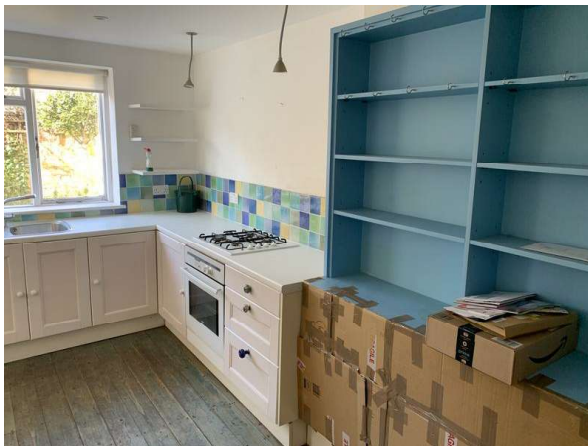
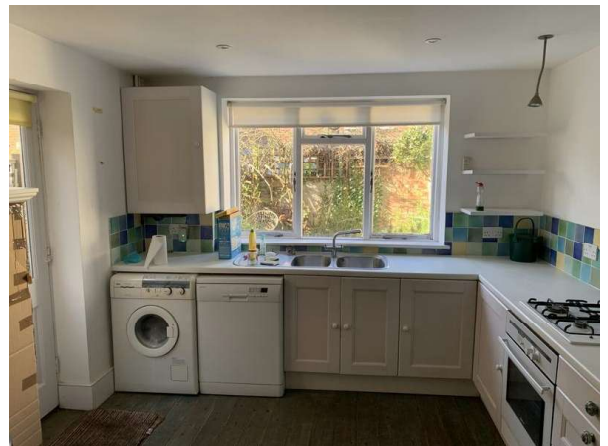
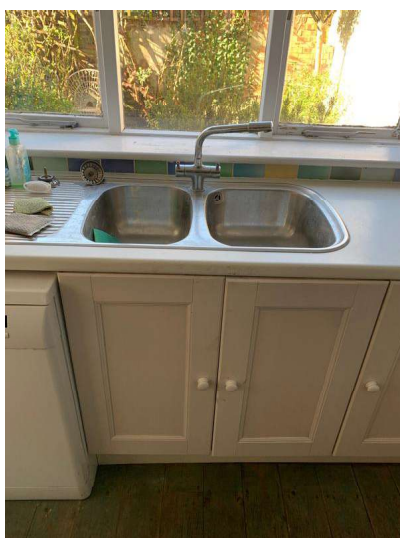
Photo 54

The kitchen fittings are worn and dated. You will no doubt want to modernise and upgrade the kitchen to your own standards.

Photo 56 - Kitchen sink

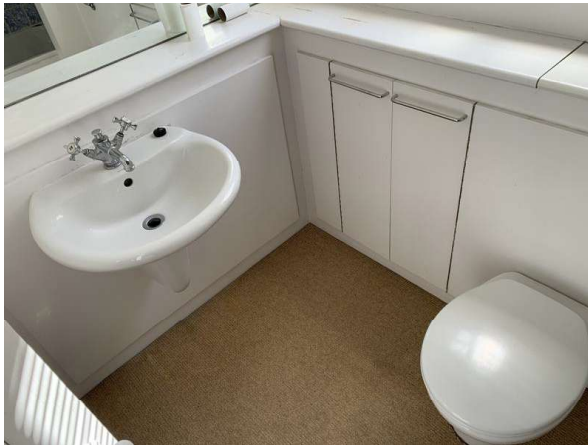
The fittings are generally low quality, low standard units and we would recommend that these are replaced.

Photo 57 - Sink/ WC

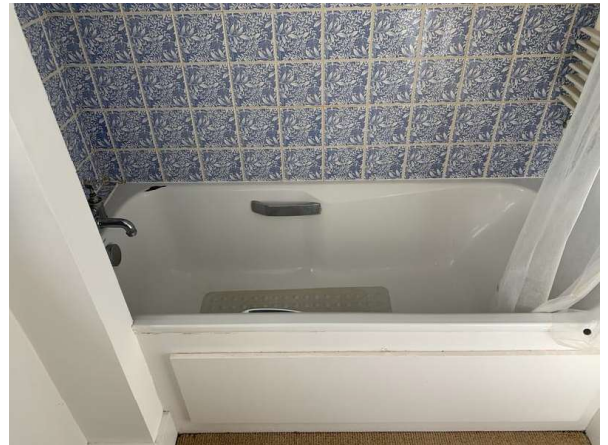
This bathroom contains a white suite consisting of an acrylic bath with mixer tap and a separate thermostatically controlled shower discharging over the bath, a WC with concealed cistern and a wall hung ceramic wash basin. The bath is damaged, in that the enamel is badly chipped on the rear left hand corner.

Photo 58 - Bath

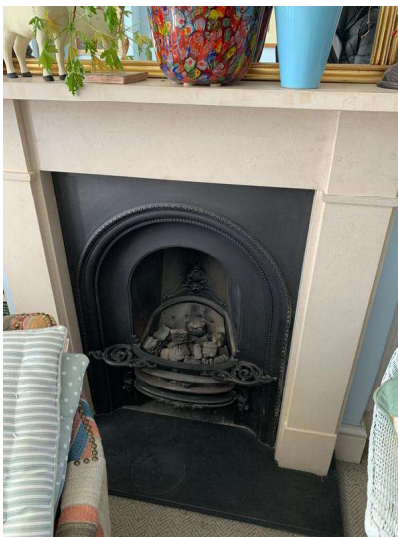
Photo 60 - Gas fire to living room

All gas fires should be tested by a Gas Safe contractor before use.

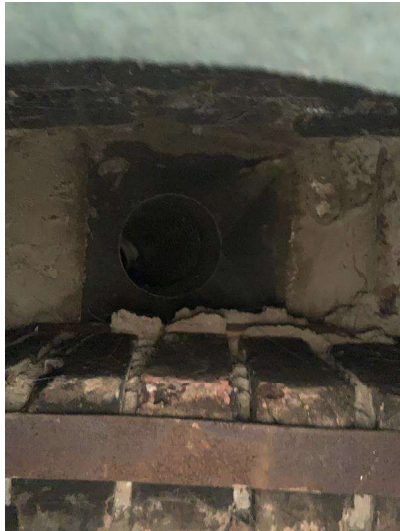
Photo 62 - Lined chimney flue

The chimney should be inspected and swept by a chimney sweep annually and before first use. Any repairs identified should be undertaken immediately.

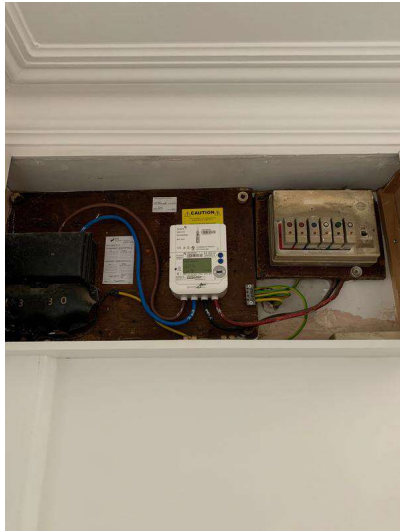
We are not aware of a current test certificate for the electrical installation.

Photo 67 - Fuse board and electric meter

In the absence of a current electrical test certificate, we would advise you to employ the services of a qualified electrician to inspect and test the wiring and to provide you with a report on its condition together with a quotation for any improvement works found necessary.

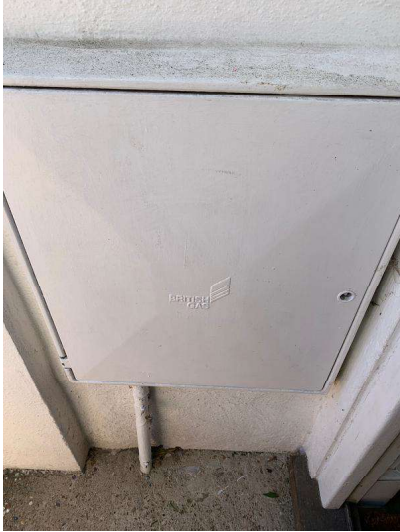
We are not aware of any up to date test certificate for the gas services.

Photo 68 - Gas meter

You should instruct an appropriate Gas Safe registered engineer to test and report on the gas installation prior to occupation.

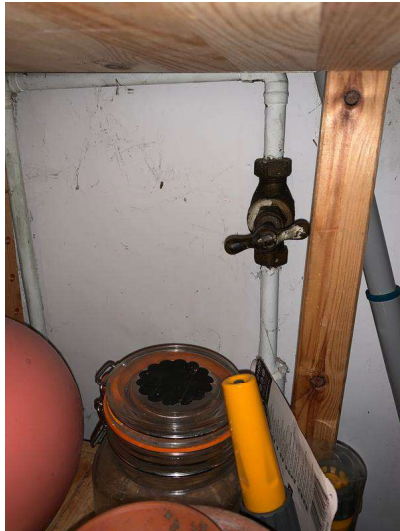
The stopcock can be found under the stairs.

Photo 69 - Stopcock

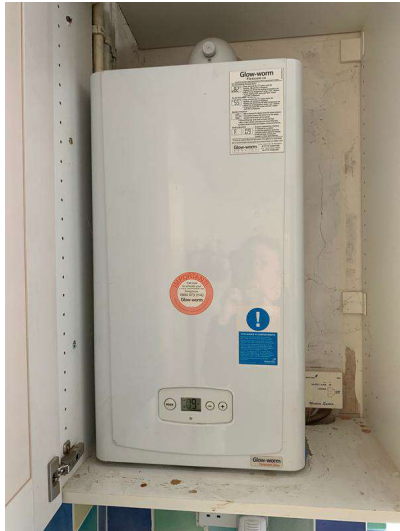
Photo 71 - Glowworm boiler

You can't always be sure when the appliances and pipework were last serviced and checked. The vendor should be able to provide you with a Gas Safety Record showing that a suitably qualified Gas Safe registered engineer has checked the gas installation pipework and appliances.

If they are unable to do this, you will need to contact a registered engineer to test and report on the system before you exchange. The engineer should be able to complete a record and provide it to the vendor so they can pass it onto you when you move into the property. The system should then be inspected annually.

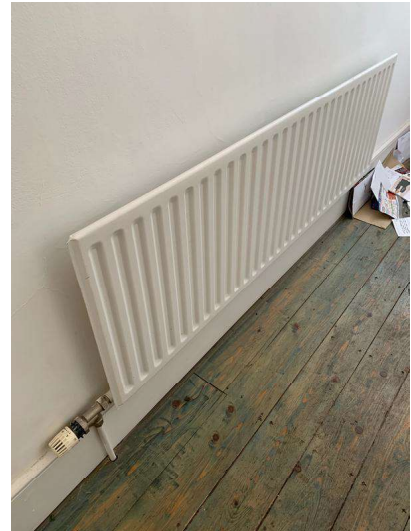
Photo 72 - Typical radiator

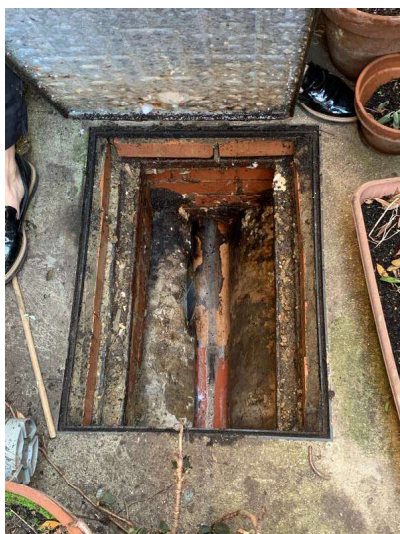
We were able to inspect the drainage system via the inspection chamber. Here we found the system to be clear and free from defects but cannot comment upon the whole system.

Photo 73 - Inspection chamber

As the drains will be of some age it would be prudent to instruct a drainage contractor to carry out a CCTV inspection of the system prior to exchange of contracts.

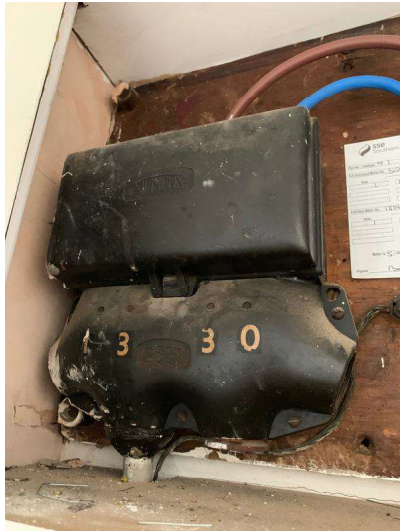
We were not able to detect the presence of any hazardous or deleterious materials that may have been used in the construction of this building, or that may have subsequently been incorporated.

Given that hazardous or deleterious materials may be hidden in the structure in inaccessible places, and the restrictions on our inspection, we cannot guarantee that no such materials exist in this building.

Photo 74 - Electricity head: possible asbestos
