LEVEL 2

Your survey report

1 Smith Road, London, AB1 2CD

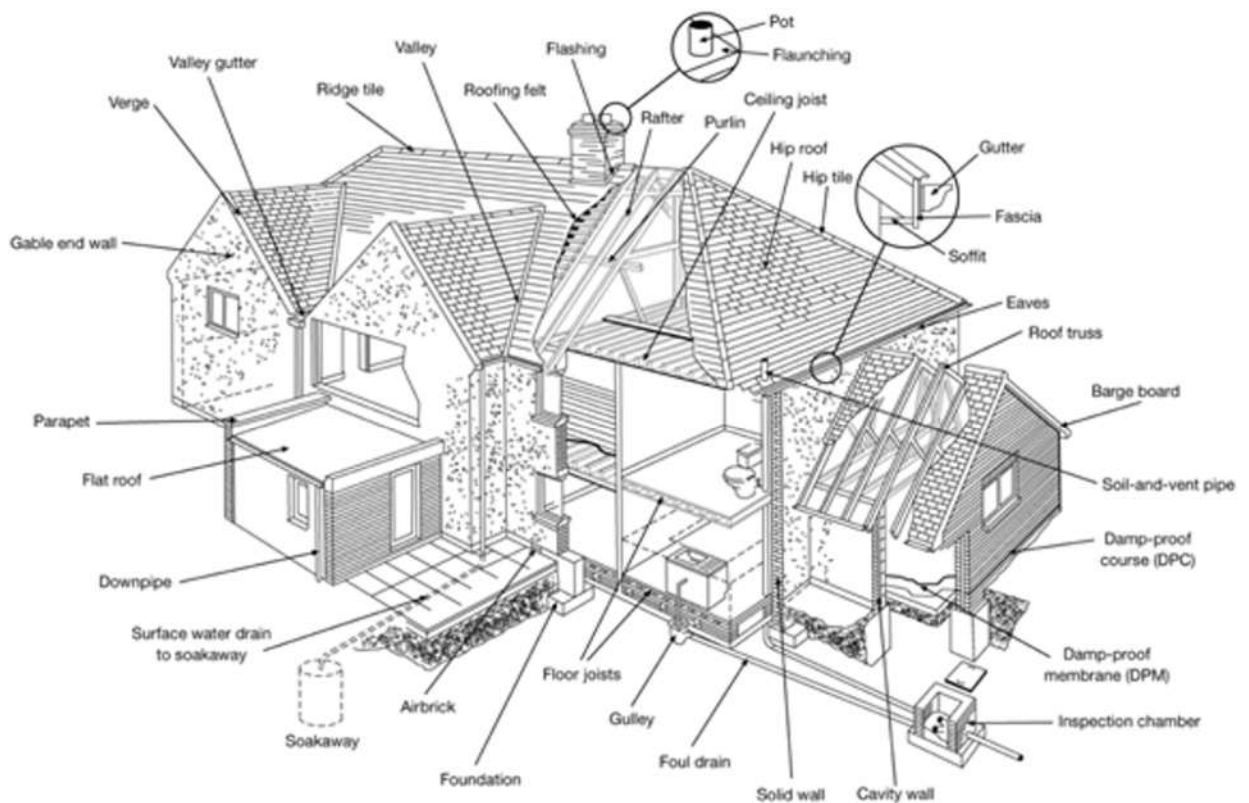
Typical house diagram

This diagram illustrates where you may find some of the building elements referred to in the report.
